Extraordinary maintenance work carried out on the arch of Titus in Rome

Abstract

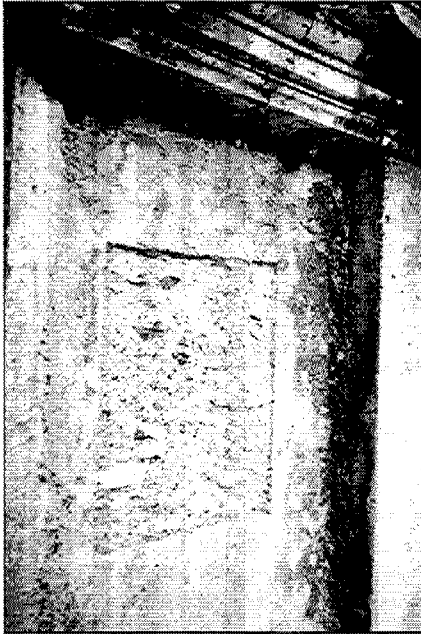
Figure 1

The static assessment concerned the state of conservation of the monument as a whole and in particular the south pillar, which had a deep crack in the base of the travertine column on the side facing the Colosseum and some extensive patterns of cracks in the travertine slabs. Furthermore a careful analysis was made of the intrados of the archway vault, which revealed disintegration and disjuncting in the voussoirs. Finally the poor state of surface conservation of original and 19th century stonework required scrupulous examination in situ to establish the true stability of the individual components and the measures to be taken to ensure an adequate conservation and safety coefficient for the monument.

Our detailed assessment of the monument made it possible to establish the state of deterioration of the travertine slabs incorporated by Valadier. The principal cause was the action of atmospheric agents which have not only corroded the external surface of the stonework but also caused the various components to become disjunct. This has led to infiltration by rainwater, causing the thick metal brackets inserted to fasten the slabs to the original masonry to become rusted. One of the travertine slabs was removed, revealing both the swelling of the metal brackets, causing localised fractures in the slab, and also the excellent state of conservation of Valadier's integration of the ancient stonework to provide a smooth bed for the new facing (figure 1). We found that the rusting of the metal brackets was the prime cause of the deterioration of the modern facing. This could be observed both in its manifest effects and by means of a large magnet with which it was possible to locate all the brackets and ascertain that they corresponded to the crack patterns. The deep fracture in the base of the column on the side facing the Colosseum was also found to be due to metal elements inside the structure, but this was not investigated more closely for fear of causing further damage (figure 2).
