Seismic rehabilitation of cathedral towers in Peru

D. Torrealva¹, A. Blanco¹, G. Tumialan² & A. Nanni²

Abstract

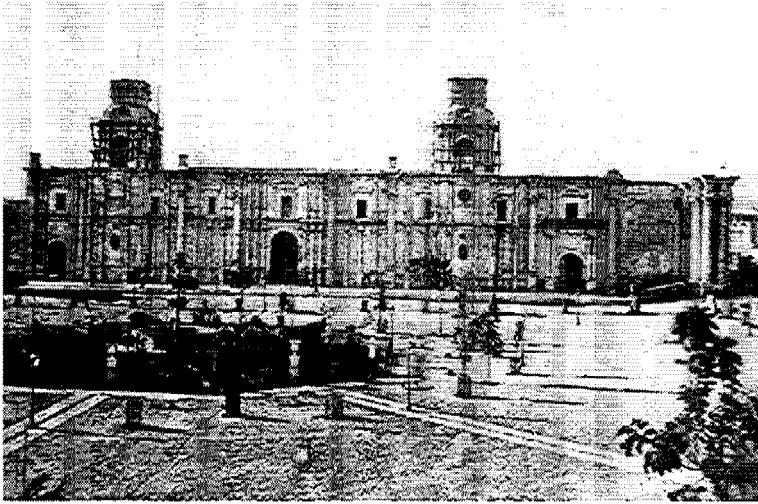
Figure 1: Reconstruction after 1868

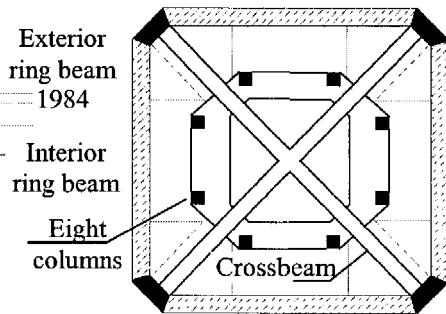
Figure 8. : Left Tower Level 2

In the bottom pillars, an additional column was placed in the exterior corner (Fig.7). This was the only corner left without support from previous interventions. The column was anchored to the existing concrete base and extended all the way up to the second level at which it was connected to a new cross beam through the mentioned holes in the second body (Fig.8). From this level, eight RC columns, with a square section of 25 by 25 cm. and four bars of 16 mm in diameter were placed coincident with the projection of the eight small pillars in the third body.
