BUILT HERITAGE IN THE 2020 EARTHQUAKES IN ZAGREB AND PETRINJA, CROATIA: EXPERIENCE AND CONSEQUENCES

JOSIP GALIĆ, DAVOR ANDRIĆ, LUCIJA STEPINAC & HRVOJE VUKIĆ

Department of Architectural Technology and Building Science, University of Zagreb, Croatia

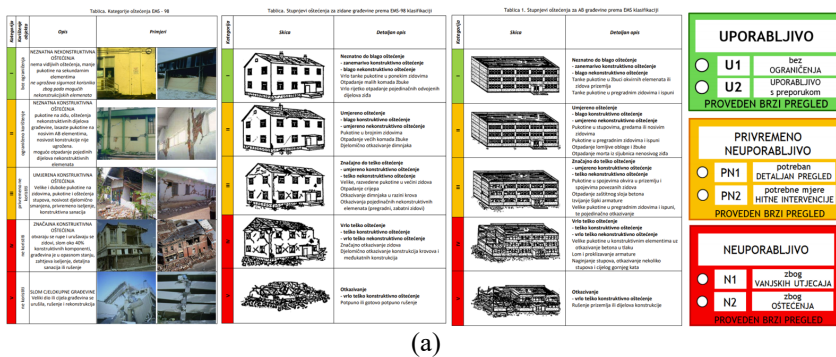
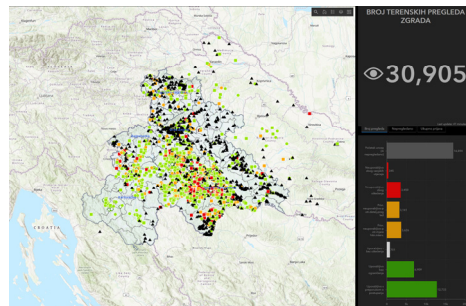
In the period from March 22, 2020, till July 01, 2020, rapid damage inspections were conducted according to EMS classification under the guidance of Croatian Centre for Earthquake Engineering [10]. The Same Centre created a manual and a form – by adapting the existing form used in Italy – for conducting the inspections [11]. Buildings were issued a green, orange (yellow), or red label according to the estimated scale of sustained damage (Fig. 1).

Figure 1: Damage inspections. (a) Manual for rapid damage assessments [11] and total number of inspections (b) after the Zagreb earthquake, and (c) after the Petrinja earthquake [10].

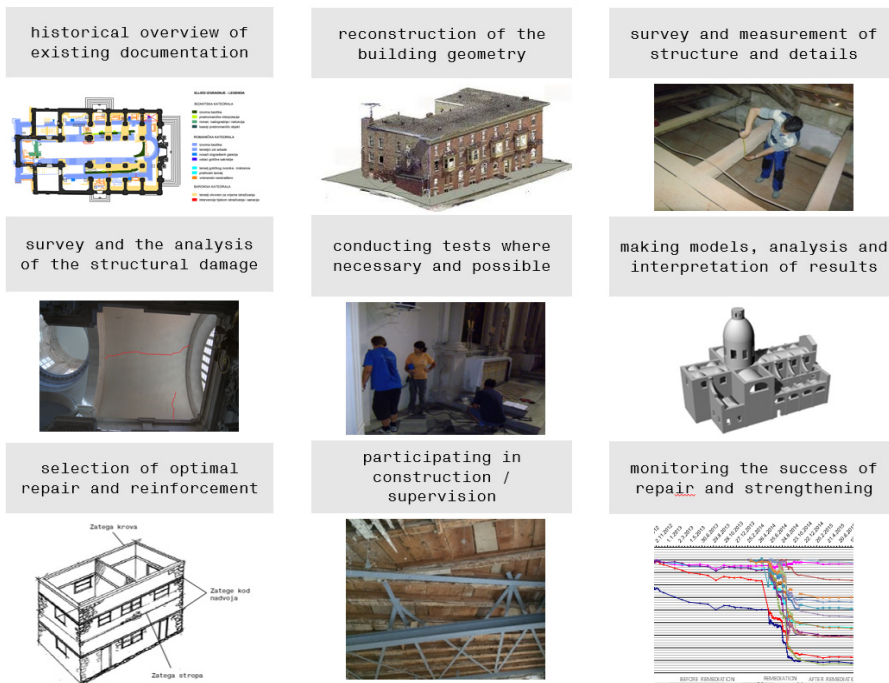
Figure 4: The process of making a project for the retrofitting and strengthening of a building [16].

In the *Techniques for the Repair and Strengthening of the Masonry Buildings*, an overview of main causes of damage and failure of masonry structures along with the overview of conventional and special techniques for retrofitting and reinforcement of masonry buildings is given. It also includes an overview of the most commonly used techniques for retrofitting and reinforcement of reinforced concrete buildings. It is supplemented with information on the process of creating a project for the retrofitting and strengthening of the load-bearing structure of existing buildings (Fig. 4).

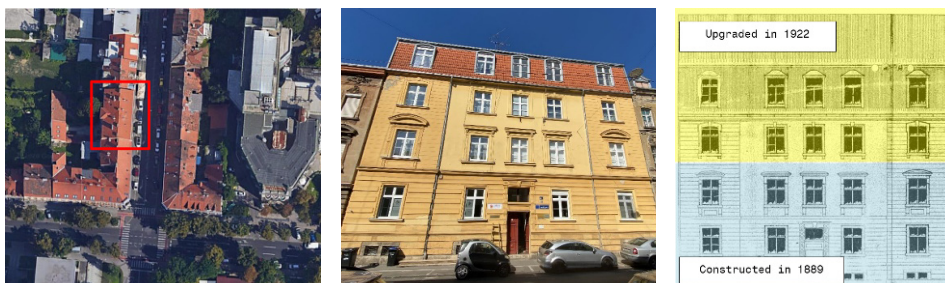
Figure 5: Case building for the simulation of retrofitting and reinforcement levels, Kačićeva 22, Zagreb, Croatia [17].

In the Manual for Seismic Retrofitting of the Existing Masonry Buildings a concrete case of a typical Zagreb historical lower-town building with masonry structure and wood ceilings (Fig. 5) was used to demonstrate different levels of interventions in accordance with the conclusions of the expert group at the Faculty of Civil Engineering, University of Zagreb, organised in cooperation with the Croatian Chamber of Civil Engineers. Levels range from basic retrofitting (Fig. 6), basic strengthening (Fig. 7), overall strengthening of existing structure (Fig. 8) all the way to the more invasive and overall reconstruction (Fig. 9). These are coupled with the cost estimate for each level with all the prices for necessary works – total estimated prices are given in Table 2.
