# The repair of english ancient monuments: two case studies

I. Hume

*Conservation Engineering Branch, English  
Heritage, UK*

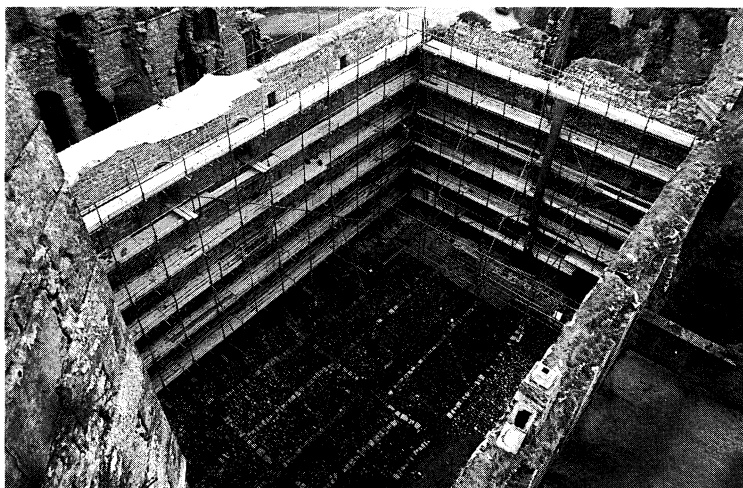
Figure 1: Looking into the courtyard.

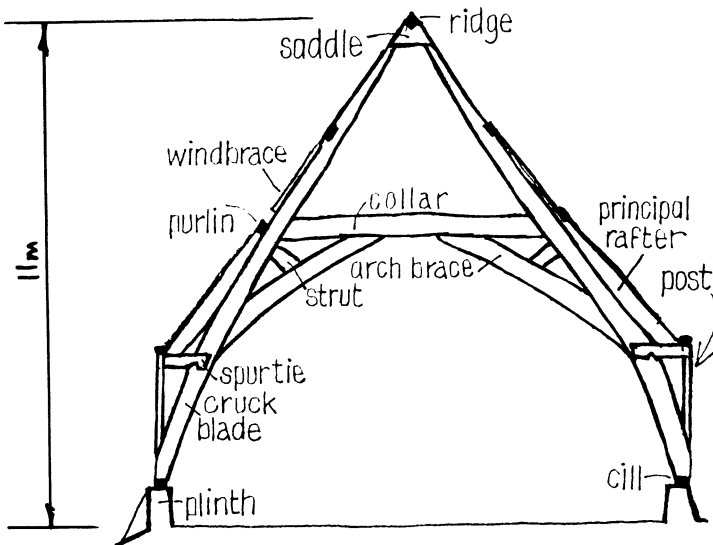
Figure 3. Cross section through barn.

The feet of the crucks sit on sole plates which in turn sit on masonry walls 500 mm - 600 mm thick, approximately 1.5 m above ground level. The bottom of these walls was only a few centimetres below ground level and the ground conditions around the barn are often waterlogged. The thrusts from the feet of the crucks had pushed out these masonry walls to varying degrees and additionally the barn had taken on a distinct lean lengthways. These quite considerable movements had caused some damage to bracing members in the timber frame and had pulled many joints apart. The first action taken was to provide substantial temporary shoring to one end of the barn to restrain its tendency to lean further and thus precipitate total collapse and prior to the work commencing in earnest, the barn was provided with a temporary cover built from steel scaffolding.

Site work commenced in the spring of 1987 and continued for 18 months. It was decided to partially dismantle the barn very carefully in order that the main cruck arch-braces could be pulled vertical, it being felt that the lean which had taken place was causing unduly high stresses any increase in which the timber framework would not be capable of resisting. All members removed from the structure were numbered so that they could be replaced in their original location this being important from an historical as well as a practical standpoint
