Scagliola or stucco marble: restoration of the altars in the church of Lichtenfels, Bavaria

C. Reithmeir

3 The restoration of the stucco marble altars in the church of Lichtenfels

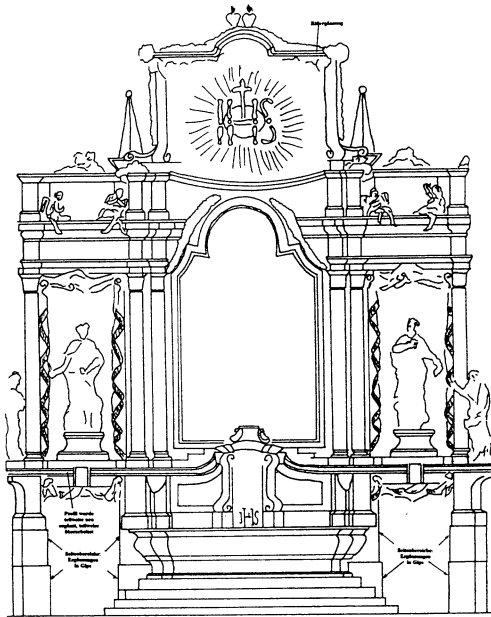
Figure 1: Church of Lichtenfels, main altar in the choir (sketch)

Damages: The most interesting object concerning the condition and the restoration itself is the main altar in the choir. Therefore, the following explanations will only refer to this altar. The object shows a wide range of damages which appear normally on stucco marble. They have partly external causes, such as mechanical stress or changes in the statics of the construction.
