The collapse and proposed restoration of a prehistoric megalithic structure

A. Torpiano

Institute for Masonry and Construction Research, University of Malta, Malta

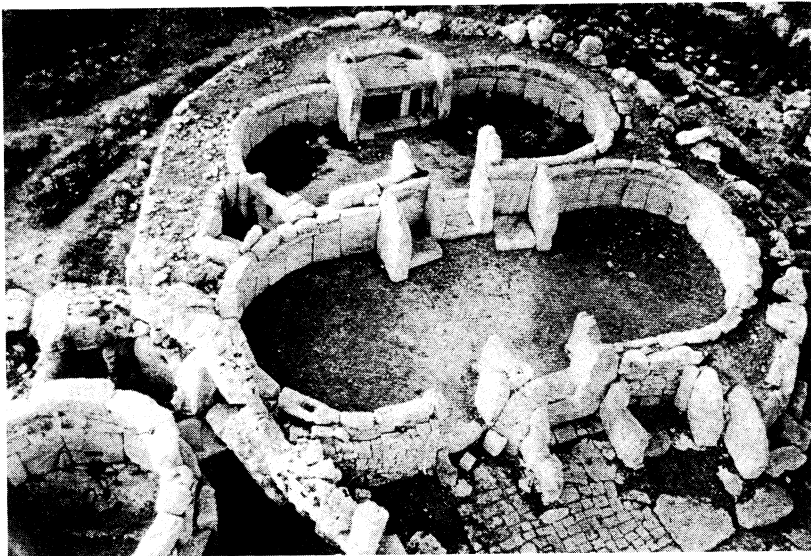
Plate 1. Aerial view of the Middle Temple, Mnajdra - National Museum Archives

The current configuration of the outer perimeter of these temples is obviously the result of an extensive amount of speculative reconstruction, carried out in the first half of the century. This can be ascertained by comparing the plan and section drawn after the first excavations of 1910, and those made in 1971. The older parts of the temples, to the south, show the alternating radial and tangential massive blocks, that are also more clearly apparent in the convex parts of the external walls of the Ggantija temple complex in Gozo⁶. The construction of the outer north wall also shows the same system, albeit in more restrained form. This is partly visible in Plate 1, and clearly in Fig. 1.
