# **Rehabilitation at Hondarribia Castle, in Hondarribia, Guipuzcoa.**

A. Abasolo

#### **4. The 1990 rehabilitation project**

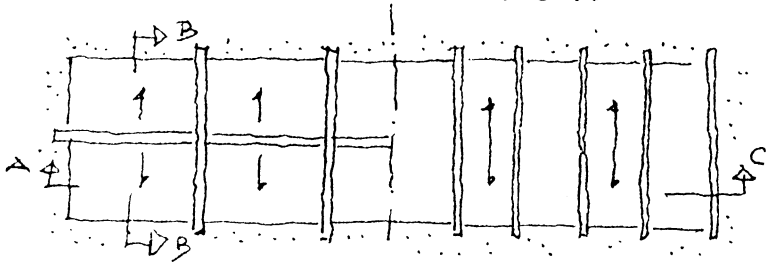
(Figure 2)

INTRADOS REINFORCEMENT

EXTRADOS REINFORCEMENT

The solution found would consist in arranging cross joists (parallel to the floor direction) in IPN 330 profiles, supported by vaulted niches made in the walls every 5 metres and by a continuous longitudinal IPN 300 header beam which would prop up, in the centre, the floor joists.

A solution was then found from the lower side by means of a mixed system based on IPN 200 joists (of the same height as that of the floors), inserted every 2.50 metres in the spaces between the floor mouldings which were concreted to a skin reinforcement frame, creating genuine (or encased) rat-joists. With T 80.80 connectors, and like a compression head, a 10cm. doubly reinforced steel

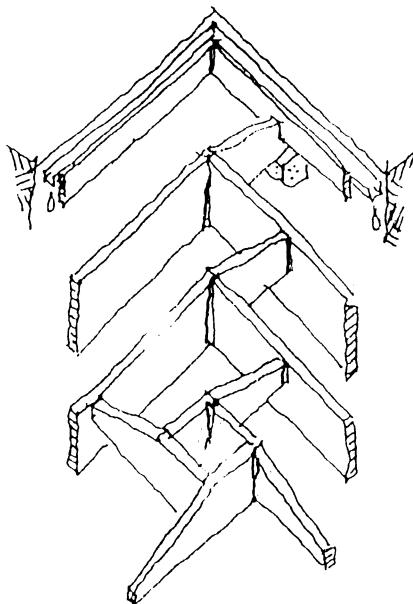
Detail (Figure 7)

Illustration 3: Glazed enclosure of the courtyard

In order to make up for this deficiency, it was only possible to cover the courtyard, and for this purpose a light, glazed structure was designed which would not only facilitate active use of the courtyard but also fit in with the surrounding architecture as a whole.
