PERFORMANCE ASSESSMENT OF ITALIAN SCHOOL HERITAGE ARCHITECTURE BY NON-DESTRUCTIVE INVESTIGATION

F. FATIGUSO, M. DE FINO & A. SCIOTI

Department DICATECh, Polytechnic of Bari, Italy

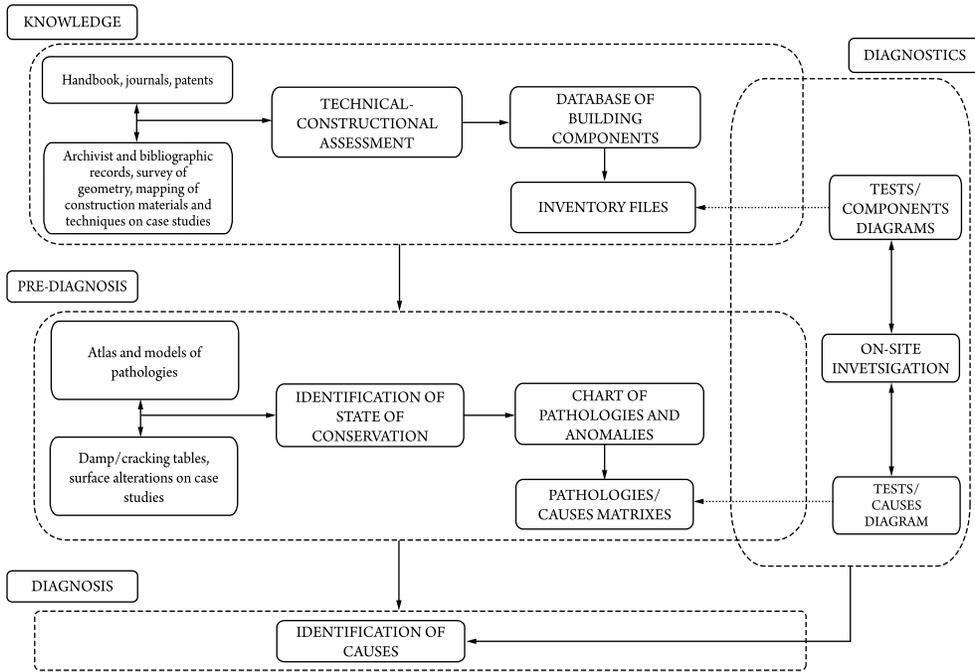
Figure 2: Methodology scheme.

The methodological process (Fig. 2), comprising the well-established phases of knowledge, pre-diagnosis, diagnostics and diagnosis, is based on the integration of sources from the technical and scientific literature with records, analyses and measurements on the case studies. In detail, it addresses the *technical-constructional assessment* of the building components, the *identification of the state of conservation* and *on-site investigation*, towards the *identification of the causes*.

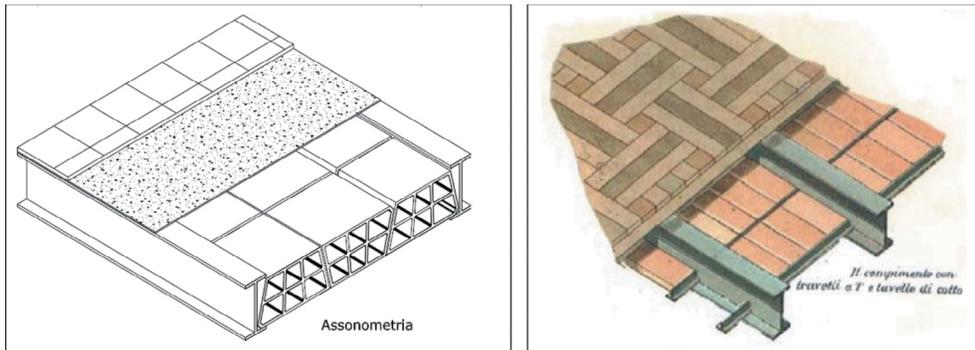
Figure 3: Record in the *database* from a *historic handbook* [16] – Slab B2b.

incompatibility between iron and wood [15]. At this stage, tufo, brick and cement elements were used. The most common elements were bricks, in the shape of small vaults (B2a), hollow tiles (B2b) and hollow blocks (B2c), as in Figs 3–4 [16].

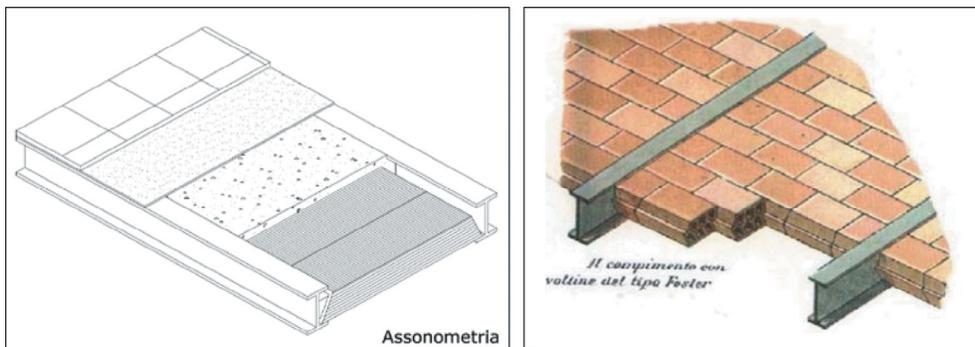
Figure 4: Record in the *database* from a *historic handbook* [16] – Slab B2c.

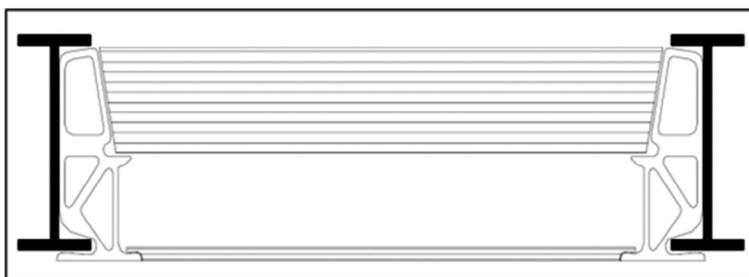
Especially for bricks, which could guarantee greater lightness, elasticity and resistance [17], several patents were registered. Among them, for instance, the slab by Ditta Frazzi was made of iron I-beams and hollow brick tiles, with a special ‘brick piece’ at the beam/tile connection to protect the thermal bridge at the intrados of the beams and a ‘brick thin tile’ at the intrados to create an air gap for thermal insulation (Fig. 5).

Figure 5: Scheme of the iron/brick slab manufactured by Ditta Frazzi.

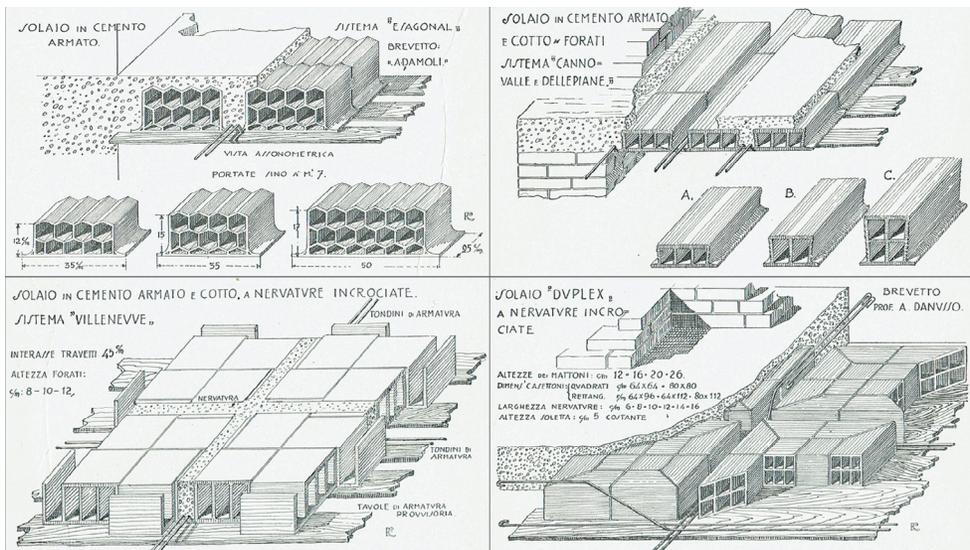
Figure 6: Record in the *database* from a *historic handbook* [20] – Slab C2.

Furthermore, the increasing employment of reinforced concrete structures initially included the introduction of continuous concrete slabs (C1), featuring high resistance, rigidity, durability, ease of installation, as well as heat and fire insulation [19]. Several patents were developed for that typology, for example, Coignet, Hennebique, Cottacin, Coularow and Walser-Gerard, which varied just in the arrangement of the reinforcement bars and brackets. Subsequently, the employment of reinforced concrete beams, in one or two directions, was exploited, with hollow brick blocks as secondary elements, with size and shape depending on the manufacturer (Fig. 6). For the last typology, the technical literature underlines the advantage of having special ‘brick pieces’ to protect the intrados of the concrete beams in order to avoid condensation of water vapour on the surfaces and facilitate the application of plaster [20].

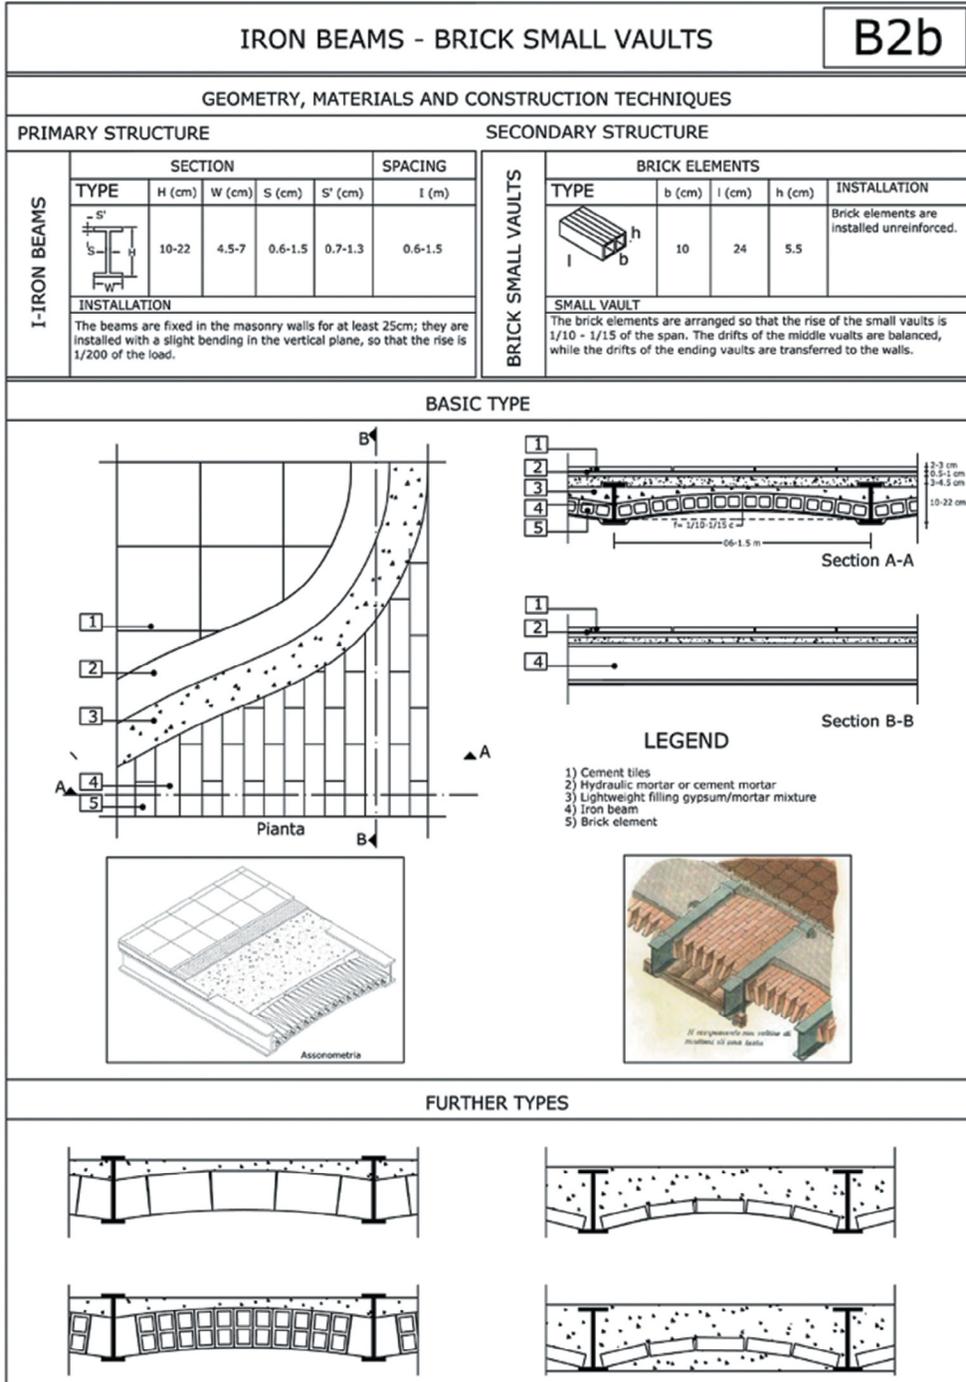
Figure 7: Inventory file – Slab B2a.

Based on the data collection and management from different sources and records, which were briefly described above, for each category/type/sub-type solution, a specific inventory file has been developed (Fig. 7), in order to feed the general database, along with the similar files for all the building components – walls, staircases and balconies.

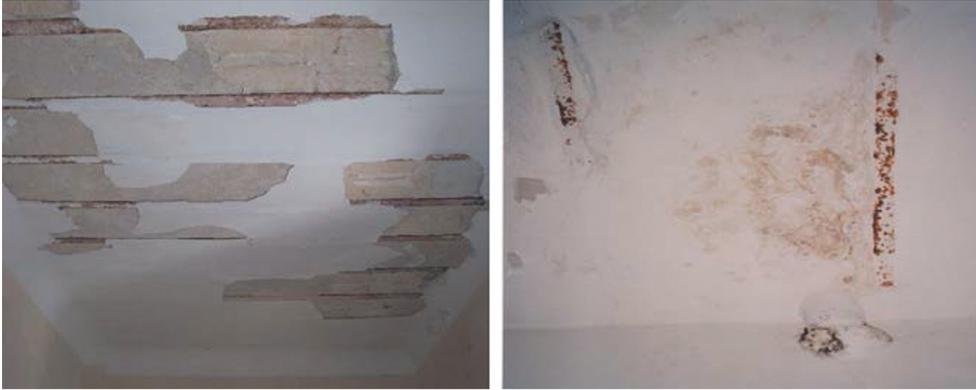
Figure 8: Record of the *chart of pathologies* (D3 and D4/5) – Slab B2.

related to *atlases* and *models of pathologies*, with specific attention towards the interfaces between different materials, in order to support the interpretation of the damage patterns due to mechanical, physical and chemical incompatibilities [21]. It is worth restating that the identification was carried out for both the primary and secondary structures, because, despite their different mechanical role, their obsolescence assessment is equally relevant to avoid local damage to the users, due to potential falling parts. In detail, concerning the slabs with iron beams, it was found that they generally show swelling and cracking of plaster at the interface between the primary and secondary structure, particularly in the case of natural/artificial blocks and cement materials. This damage pattern is due to the mechanical and physical incompatibility between different layers, the lack of protection of the iron beams at the intrados and the lack of a special 'brick piece' at the beam/brick interface. In some cases, aggressive environmental conditions have worsened the damage due to corrosion of the steel beams. Deformation of the iron beams often occurs, with subsequent cracking and detachment of the floor tiles at the extrados and, in the case of small brick vaults, fractures of the brick elements at the interface with the beams. Such damage is generally related to insufficiently resistant sections, considering the working loads and the slab span, and to mechanical-chemical-physical incompatibility between different layers. The mechanical incompatibility of the floor tiles at the extrados has accentuated the damage in some cases. All the slabs with iron beams also show several alterations of the primary structure, in terms of corrosion, with subsequent surface stains and deterioration at the intrados, as well as reduction of the resistant sections in the most severe cases. Whenever the secondary structure is made out of steel sheets, it has also undergone corrosion. Such damage is caused by aggressive environmental conditions, lack of maintenance and/or inadequate cleaning of the floor tiles at the extrados. Several damage patterns result from condensation of water vapour on the surfaces, particularly for iron beams and metal steel sheets, if they are not properly protected at the intrados or the maintenance has not been regular and effective. Furthermore, cracking all over the secondary structure, especially in the slabs with cement materials, results from chemical-physical incompatibility between different layers, over-deformability of the iron beams, inadequate manufacturing, installation and/or curing of the concrete and loads exceeding the designed levels. Similarly, concerning the slabs with reinforced concrete beams, surface stains and deterioration, as well as cracking and detachment of the plaster, appear due to mechanical-chemical-physical incompatibility between different layers and poor maintenance. Whenever the concrete covers are missing, crumbled or incoherent and the concrete elements have undergone fracture and delamination, again inadequate manufacturing, installation and/or curing of the concrete, loads exceeding the design, insufficient resistant sections and corrosion of the metal bars might happen. The same factors cause the fracture of brick elements in the secondary structure. The correlation matrix in Table 2 summarizes the most commonly recurring damage patterns and relative possible causes for iron/brick and concrete/brick slabs. Similarly, to the inventory files in the database for the technical-constructional assessment, this matrix, which was developed for all the building components (walls, staircases and balconies), is linked to charts of pathologies, as detected in the case studies and shown in Figs 8 and 9.

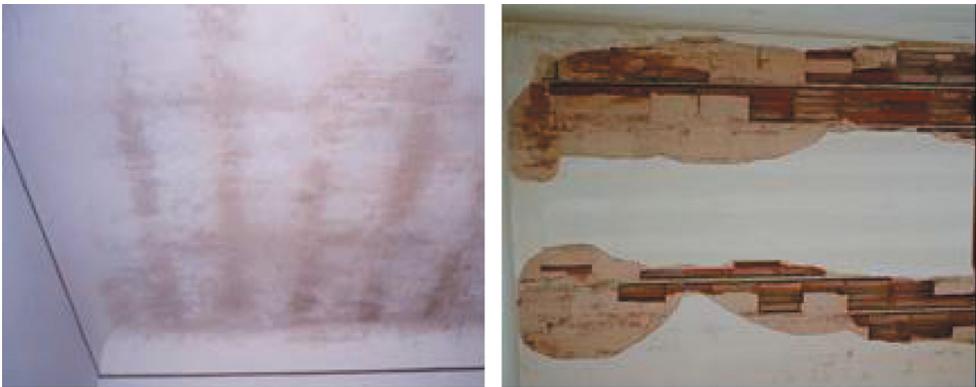
Figure 9: Record of the *chart of pathologies* (D3 and D7) – Slab C2.

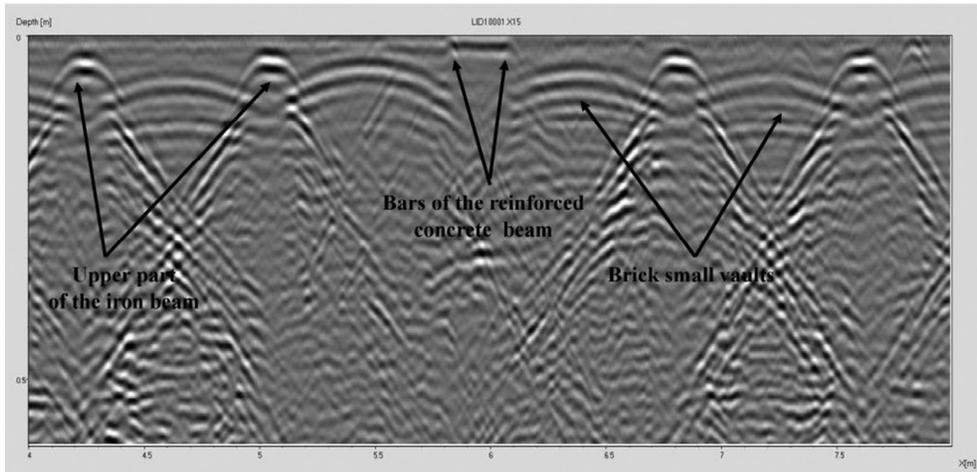
In order to better explain the efficacy of radar scanning, Figs 10 and 11 show the outcome from a slab with iron beams and small brick vaults and a slab with concrete beams and hollow brick blocks, respectively. In the former case, wide reflections, in the shape of hyperbola, occur on top of the iron beams. Curved reflection profiles are visible, as well, corresponding to the brick small vaults. In the specific application, Fig. 10 also shows the presence of

Figure 10: Record of the *repertory of radar measurements* – Slab B2a.

a reinforced concrete beam whose upper reinforcement bars result in two small hyperbolas, just below the investigation surface and right in the middle of the displayed radargram. In the latter case, the radargram shows closer and smaller reflection hyperbola, reasonably due to the lower thickness of reinforcement bars in the concrete beams of the slab. Moreover, above the hyperbola, areas with low reflection/high transmission would correspond to the concrete beams themselves. Differently, small reflection planes, due to the holes in the brick blocks, characterize the contiguous areas.

According to the discussed issues, Tables 3 and 4 summarize the height of priority – increasing from 0 to 10 – of different techniques for the elements and the pathologies, respectively. Those tables are related to repertoires of experimental measurements, which include diagnostic data, such as those displayed in Figs 10–12.

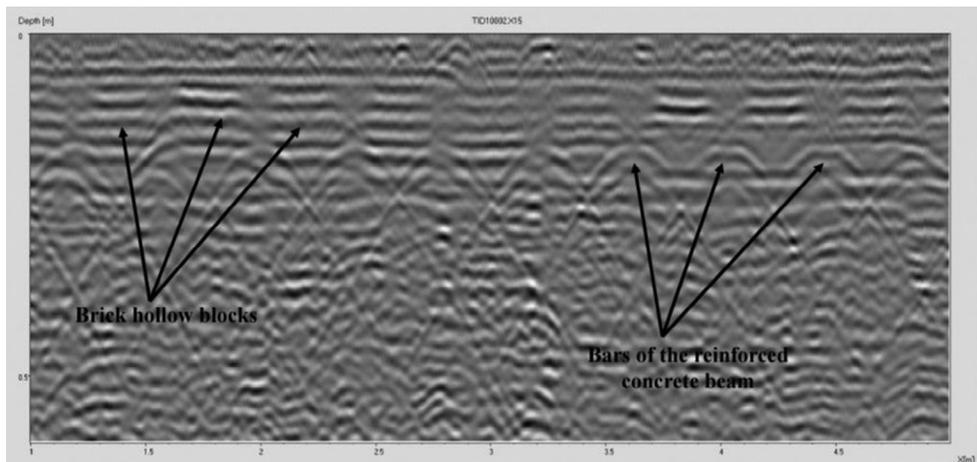
Figure 11: Record of the *repertory of radar measurements* – Slab C2.

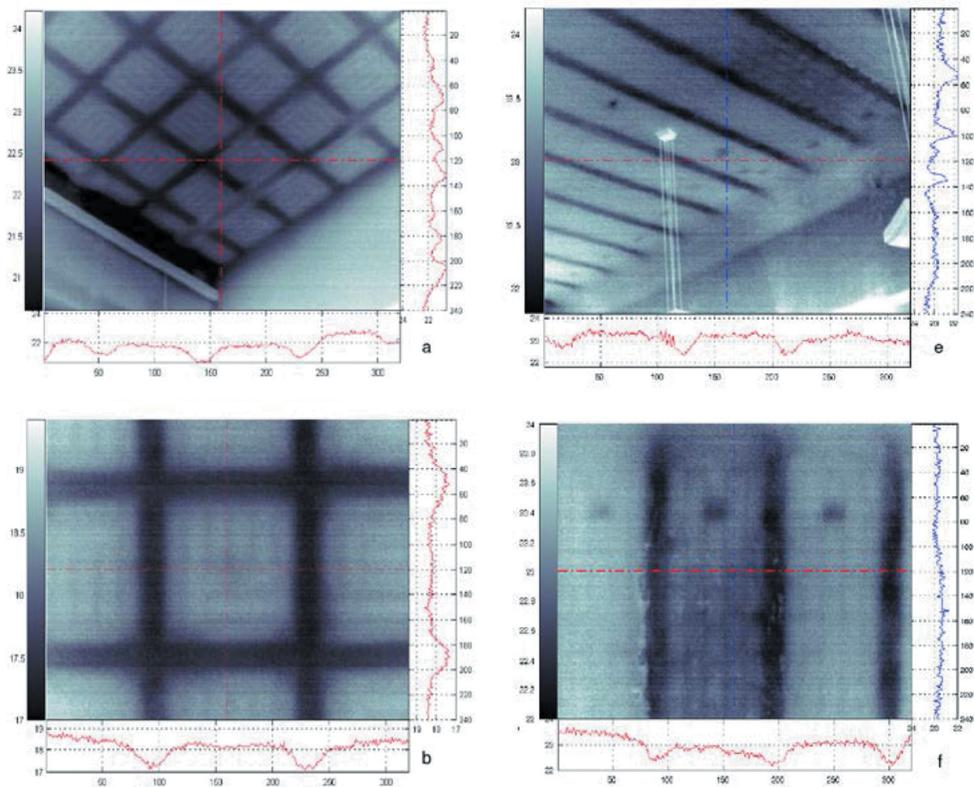
Figure 12: Record of the *repertory of thermography measurements* – Slabs C2 and B2a.

In order to better explain the efficacy of the thermography, Fig. 12 shows some thermograms. Particularly, the thermograms where the picture plane is parallel to the intrados surface enabled to measure the dimensions of the elements, known the distance and the view factor of the thermocamera.

The technical-construction assessment of the building components can also be achieved by thermography. The technique should be used to investigate the intrados, in passive or active mode, according to the surrounding environmental conditions [23]. The method relies on the detection of the emitted radiation in the infrared spectrum due to the surface temperature. Consequently, it enables the identification of the morphology of the primary and secondary structure at the intrados. Again, it can provide reliable data if the materials are different, in
