Challenges of cost-effective high-performance residential construction on the US market: lessons learned from building Utah's most energy-efficient and cost-effective house

J. Rügemer

School of Architecture, University of Utah, Salt Lake City, USA

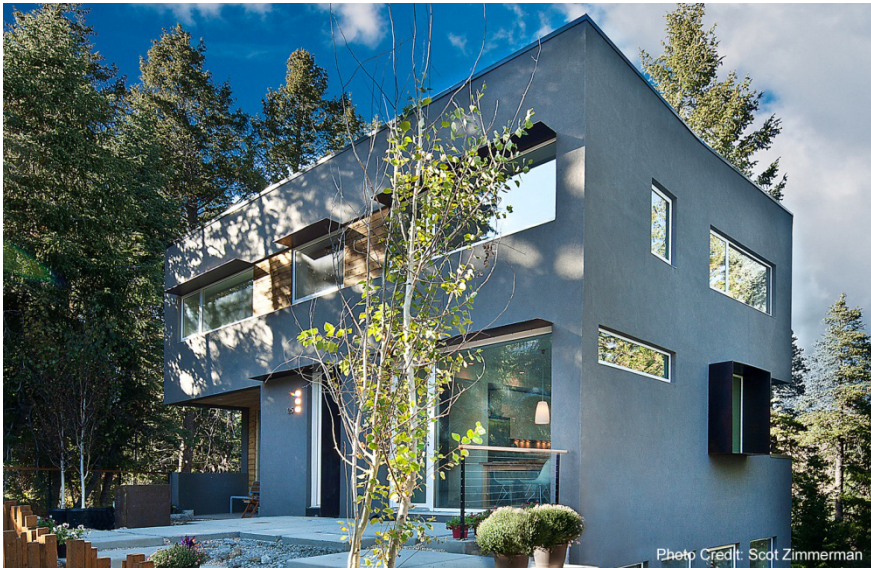
Figure 1: 125 Haus in Park City.

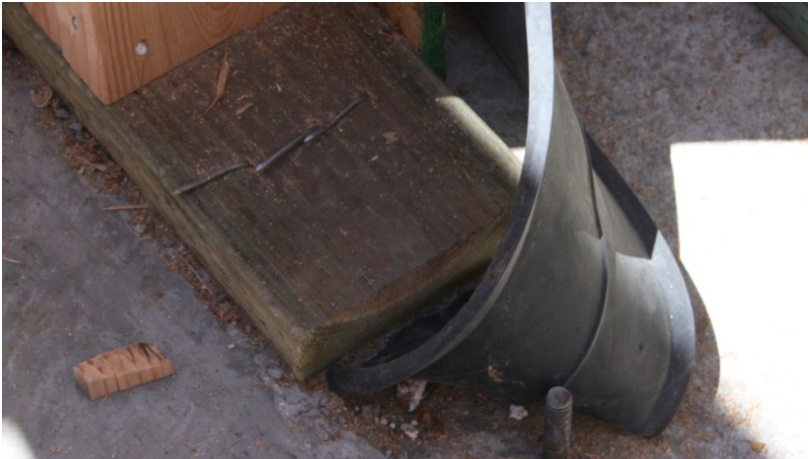
Figure 3: Rubber gasket between sill plate and concrete.

2. *An airtight fit* between concrete foundation and stem walls and sill plate had to be guaranteed. Carefully smoothening and leveling the top of the walls overcame this challenge; using a 15cm wide EPDM rubber gasket between concrete and sill plate compensated for irregularities (Figure 3). Any remaining gaps between foundation and walls were sealed with acoustical sealant and foam.
3. *A radon gas protection layer with over-the-roof exhaust* was installed under the floor slab. Plastic sheeting was installed between gravel and under-floor slab insulation, with the edges pulled over the stem and foundations walls to be later covered by the sill plates and gaskets. After the slabs were poured, workers removed the protruding plastic along one side before the A/O could stop them. The defect needed to be hand sealed before the sill plates went in, to ensure proper performance of the system.

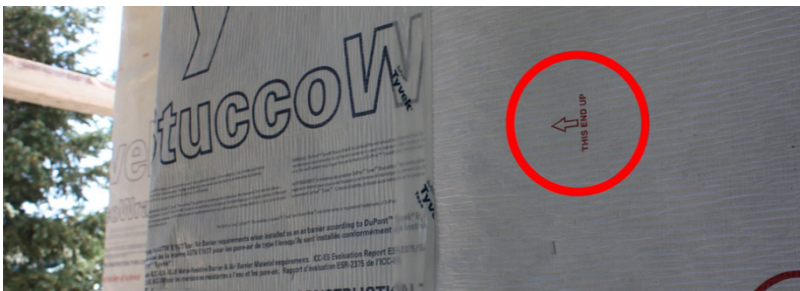
Figure 4: Improperly installed Tyvek.

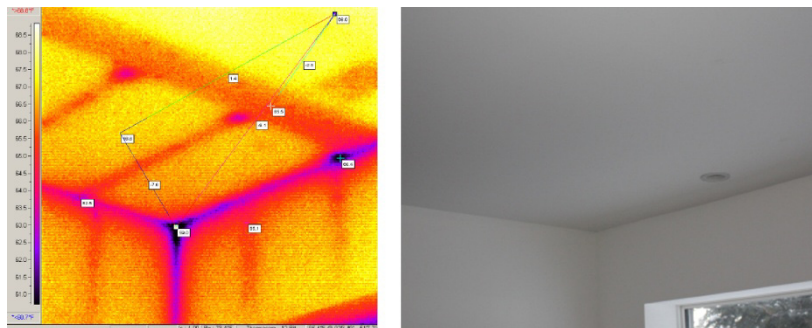
Figure 5: Thermal image of ceiling under deck.

3. Conditioned spaces are located above and below the two exterior patios. Due to the building's height restrictions, the effective thickness of insulation is as low as 14cm in one case, which was an issue accepted by design. The thermal imaging analysis showed no considerable drop in surface temperature though, averaging 1,5°C only (Figure 5).
