Fatigue damage formation and microstructure of ultrafine grained copper under two-step loading

Abstract

Keywords: *ultrafine grain, copper, fatigue, two-step loading, surface damage.*

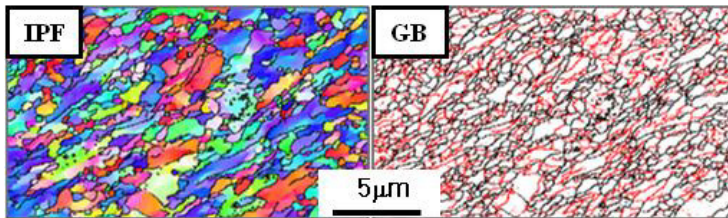
Figure 2: The OIM orientation and GB maps for as-receive UFG copper.

Fig. 2 shows the inverse polar figure (IPF) map and grain boundary (GB) map of an ECAP rod. The microstructure included fine equiaxed grains with about 300-nm diameter, and large elongated grains. The pre-ECAP mechanical properties were 232 MPa tensile strength, 65% elongation, and Vickers hardness of 63 (load: 2.9 N). After eight ECAP passages, the properties changed to 438 MPa, 28%, and 141, respectively.

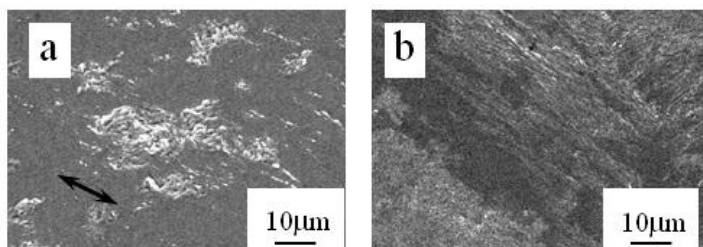
Figure 3: SEM micrographs of surface damage of specimens fatigued under constant stress amplitudes; (a) $\sigma_a = 240 \text{ MPa}$, (b) $\sigma_a = 90 \text{ MPa}$. Shear direction of the final pressing.

Fig. 3 shows SEM micrographs of typical surface damage of the specimens fatigued under constant stressing. The surface after the constant stressing of $\sigma_a = 240 \text{ MPa}$ (Fig. 3(a)) consisted of fine line-like protrusions formed at early fatigue stages, and island-like protruded areas formed at later fatigue stages [13]. The line-like protrusions are straight and approximately parallel to the shear plane of the final pressing (as indicated by the arrow). This morphology of protrusions would place them into the persistent slip bands (PSB)-like SBs category [6]. At constant stressing of $\sigma_a = 90 \text{ MPa}$ (Fig. 3(b)), the post-fatigued surface was covered with island-like damaged areas, and the diameter of large areas far exceeded 0.1 mm. The damaged areas contained a high density of fine/shallow protrusions.

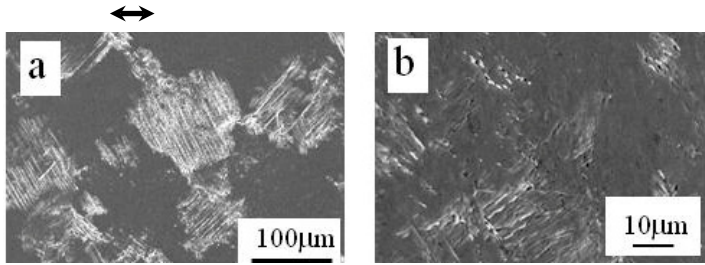
Figure 4: SEM micrographs of surface damage of specimens fatigued under two-step loadings; (a) $\sigma_a = 90 \rightarrow 240$ MPa, (b) $\sigma_a = 240 \rightarrow 90$ MPa.

To clarify the physical basis of different features of surface damage between the high- and low-stress amplitudes, two-step fatigue stress tests were conducted. After the repetitions of an arbitrary cycle-number at the first stress amplitude (σ_{a1}), the specimens were fatigued at the second-stress amplitude (σ_{a2}). Figs. 4(a) and (b) show the surface damage under low-to-high and high-to-low block (L-HB

and H-LB) stress. In L-HB stressing (Fig. 4(a)), after 2.2×10^6 repetitions of $\sigma_{a1} = 90$ MPa (at this stage, a crack from a hole reached 0.59 mm in length), the specimen was fatigued at $\sigma_{a2} = 240$ MPa. Fatigued surfaces under L-HB stressing had island-like damaged areas with size ranging from 10 to 100 μm . A magnified view of the damaged area indicated that slip-bands developed inside the coarsened grain. In H-LB stressing (Fig. 4(b)), after 5.3×10^4 repetitions of $\sigma_{a1} = 240$ MPa (at this stage, a crack from a hole reached 0.53 mm in length), the specimen was fatigued at $\sigma_{a2} = 90$ MPa. For the H-LB stressing, PSB-like SBs formed under the first high-stress repetitions, and the plate-like protrusions that formed under the subsequent low-stress repetitions were distributed throughout the fatigued surface. The plate-like protrusions exit the matrix at an incline, forming a terraced field of overlapping plate-like protrusions. The sizes of each area covered with plate-like protrusions were roughly less than 10 micrometers.

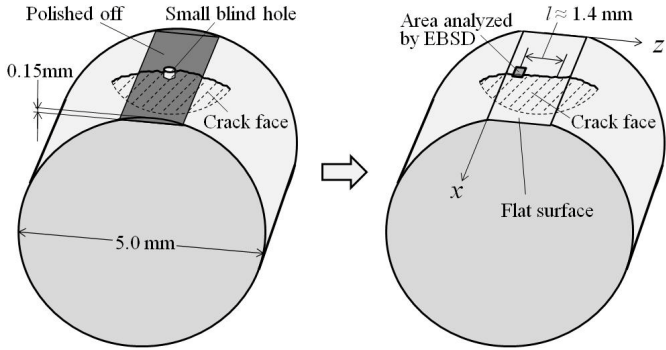
Figure 5: Illustration showing the production of a flat surface in the round-bar specimens and EBSD-analyzed area.

The EBSD analysis of post-fatigued specimen was conducted to clarify the evolution of microstructure with sub-micron ranges. In order to conduct EBSD analysis of the post-fatigued microstructure just under the specimen surface, 0.15 mm surface layer of post-fatigued round bar specimens were polished off to make a flat surface for EBSD analysis. The procedure for making the flat surface and the area analyzed by EBSD are illustrated in Fig. 5. Microstructures about 0.7 mm away from the crack initiation site (at the edge of a small hole) were analyzed.

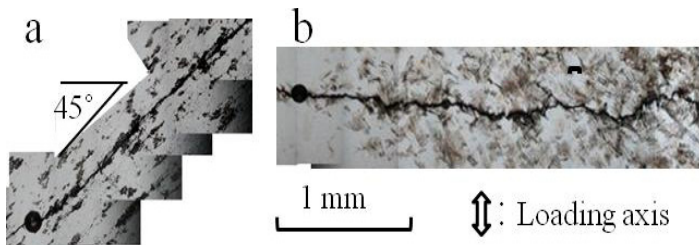
Figure 7: Crack growth paths under constant stress amplitudes; (a) $\sigma_a = 240$ MPa, (b) $\sigma_a = 90$ MPa.

Fig. 7 shows OM micrographs of the crack growth paths formed under constant fatigue stress tests. The growth direction of a crack depended on the magnitude of applied stress amplitudes. At $\sigma_a = 240$ MPa (Fig. 7(a)), the crack that initiated from the hole grew at 45° inclination from the loading axis. The inclined crack showed a linear growth path on the macroscale. In LCF tests of UFG metals [11], the 45° inclined crack growth direction has been commonly observed in the ZX-plane. Regarding the crack propagating under $\sigma_a = 90$ MPa (Fig. 7b), however, the macroscale growth direction was perpendicular to the loading axis; nevertheless, the crack grew in a zigzag manner at the microscale. The degree of zigzag growth gradually increased with an increase in crack length.

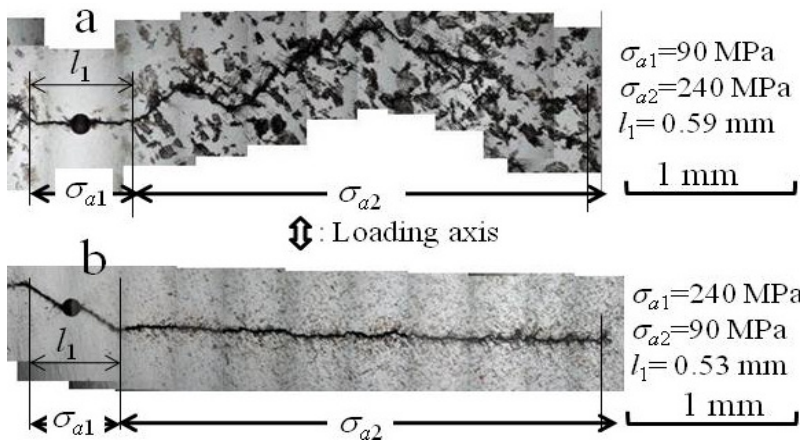
Figure 8: Crack growth paths under two-step stressing; (a) L-HB stressing ($\sigma_a = 90 \rightarrow 240$ MPa), (b) H-LB stressing ($\sigma_a = 240 \rightarrow 90$ MPa).

Fig. 8 shows the crack growth paths under L-HB and H-LB stressing. In L-HB stressing (Fig. 8(a)), the crack grew perpendicular to the loading axis under

$\sigma_{a1} = 90$ MPa and its length reached approximately $l = 0.59$ mm after 2.2×10^6 cycles. Under the second stress ($\sigma_{a2} = 240$ MPa), although the crack paths were nearly perpendicular to the loading axis on the macroscale, the crack path had many branches and meanderings, and showed a drastically large zigzag pattern. In H-LB stressing (Fig. 8b), a 0.53-mm-length crack with a growth path at a 45° incline to the loading axis was formed under 5.3×10^4 repetitions of $\sigma_{a1} = 240$ MPa. After a stress amplitude change to $\sigma_{a2} = 90$ MPa, the crack grew nearly perpendicular to the loading axis, leaving a linear crack path with very small deflections, while the crack path under the constant stress of $\sigma_a = 90$ MPa exhibited a comparatively large zigzag pattern (Fig. 7(b)).

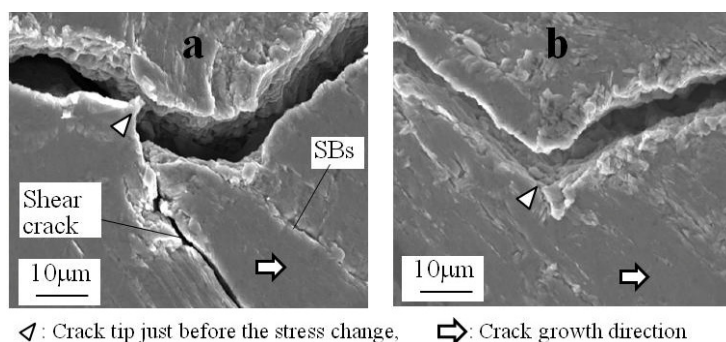
Figure 9: The SEM micrographs of the crack paths at the point that the stress changed; (a) L-HB stressing, (b) H-LB stressing.

Fig. 9 shows an SEM micrograph of the crack path at the point that the stress changed. In L-HB stressing, after the stress change (Fig. 9(a)), a shear crack formed at the major crack tip and grew along the maximum shear stress plane. Further observations indicated that the shear crack stopped propagating after it reached coarse grains. After stopping of the shear crack propagation, the SBs were initiated. After 6,000 second-stress cycles, the SB growth ceased, and the major crack changed its growth direction with a branching, followed by the crack growth with the consecutive processes of shear-crack/SB formation and crack branching. Consequently, the drastically large zigzag paths were attributed to a repetition of the crack-branching caused by SB formation, blocking growth at coarse grains and the growth along HAGBs of the coarse grains. Fatigue cracks propagate preferentially along HAGBs since they comprise weaker cohesion in their lattice structure [14]. In H-LB stressing (Fig. 9(b)), the surface at the crack edges formed under high stress was comparatively flat, whereas the surface that formed under low stress had traces of localized plastic deformations, suggesting change in the crack growth mechanism under high and low stresses. The crack growth direction just after the stress change under H-LB stressing was estimated by the local maximum tangential normal stress ($\sigma_{\theta \max}$) [15], showing the growth direction along the plane of $\sigma_{\theta \max}$ under the subsequent low stress amplitudes.
