Bond repair of cracked beams

H. Cruz¹, J. Custódio¹ & D. Smedley²

Abstract

Keywords: cracked timber beams, structural adhesives, consolidation, strength and stiffness recovery.

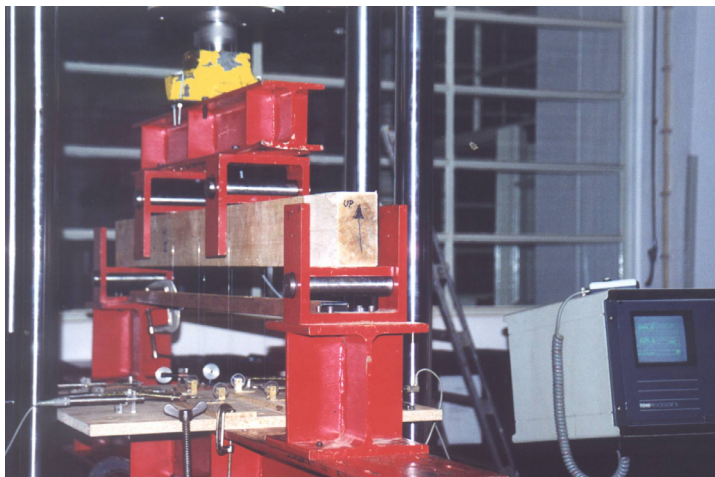
Figure 1: Test set up and specimen being tested in bending.

The 1.50 m long specimens, simply supported over a span of 1.40 m, were symmetrically loaded in bending at two points 0.50 m apart. Small steel plates, 5 cm large, were inserted between the test piece and the loading heads, and between the test piece and the supports, to minimise local indentation (figure 1).
