# EFFECT OF FINE PARTICLE PEENING USING HYDROXYAPATITE SHOT PARTICLES AND PLASMA SPRAYED HYDROXYAPATITE COATING ON FATIGUE PROPERTIES OF BETA TITANIUM ALLOY

## ABSTRACT

Fine particle peening (FPP) and plasma spraying using hydroxyapatite particles were applied to a beta titanium alloy, Ti-22V-4Al, to form the hydroxyapatite (HAp) layer on the surface. As a result, HAp layer was formed on the specimen surface by the both treatments. The thicknesses were 5  $\mu\text{m}$  and 100  $\mu\text{m}$ , respectively for FPP treated and plasma sprayed specimens. In the FPP treated specimen, Vickers hardness was increased by FPP compared with that of the untreated specimens, resulting in work-hardening. Rotary bending fatigue tests were carried out on both treated and untreated specimens. The FPP treated specimens exhibited higher fatigue strength than the untreated specimens. It is due to the increase in hardness and compressive residual stress by FPP. On the other hand, significant deteriorations of the fatigue strength for the plasma sprayed specimen was observed in comparison with the result for the untreated specimen. As a result of fracture surface observation in plasma sprayed specim

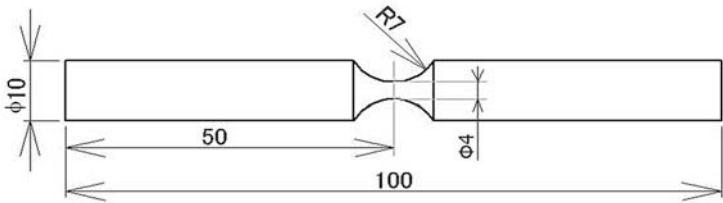
Figure 1: Specimen configuration.

mounted the specimen grips was kept within  $\pm 20 \mu\text{m}$  at the tip of each specimen. The rotating speed of the spindle is 3150 rpm. All the fatigue tests were conducted at room temperature and in laboratory environment. After fatigue tests, fracture surfaces of failed specimens were examined in a scanning electron microscope (SEM).

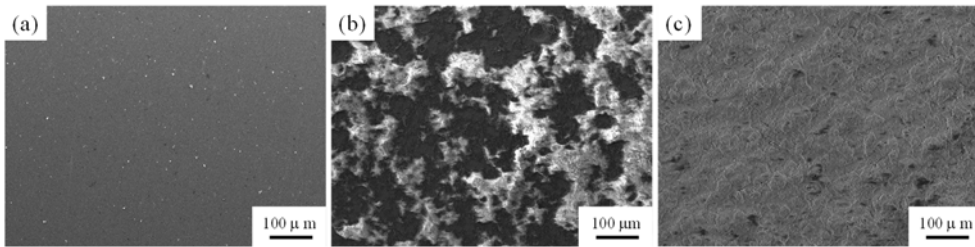
Figure 2: SEM images of surfaces. (a) Untreated specimen; (b) FPP treated specimen; (c) Plasma sprayed specimen.

Fig. 2 shows the surface of untreated, FPP treated and plasma sprayed specimen. As shown in Fig. 2(a), a smooth surface was formed by polishing for the untreated specimen. On the other hand, in FPP treated and plasma sprayed specimen, the rough surface was formed by plastic deformation due to collision of HAp particles with the specimen surface.

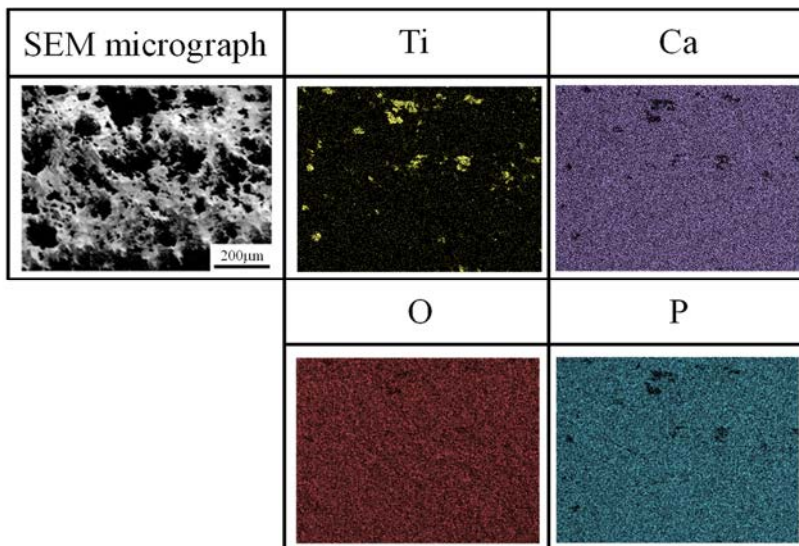
Figure 3: EDX maps for surface of FPP treated specimen.

The analysis of elements at FPP treated specimen surface was performed by EDS. Fig. 3 shows EDX maps of the FPP treated specimen surface. As seen in the figure, calcium (Ca), oxygen (O) and phosphorus (P) elements which was contained in HAp particles were

detected at the whole surface of FPP treated specimen which suggests that the HAp transferred layer was formed on the specimen surface.

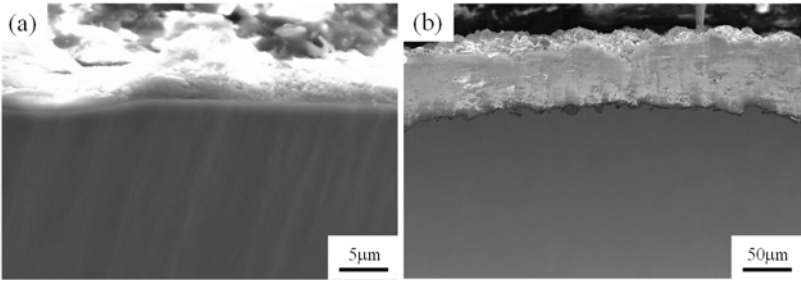
Figure 4: SEM images of cross-sections. (a) FPP treated specimen; (b) Plasma sprayed specimen.

Fig. 4 shows the cross-sections of FPP treated and plasma sprayed specimens. As seen in the Fig. 4(a), HAp layer was formed on the substrate by FPP. Thus, FPP using HAp particles can form HAp transferred layer on the specimen surface, and its's about 5  $\mu\text{m}$  in thickness. In the case of plasma sprayed specimen, thick HAp layer was formed on the substrate (Fig. 4(b)). The thickness is about 100  $\mu\text{m}$ . Furthermore, the interface between HAp layer formed by plasma spray and substrate was very rough because alumina grit blasting was performed before the plasma spray.

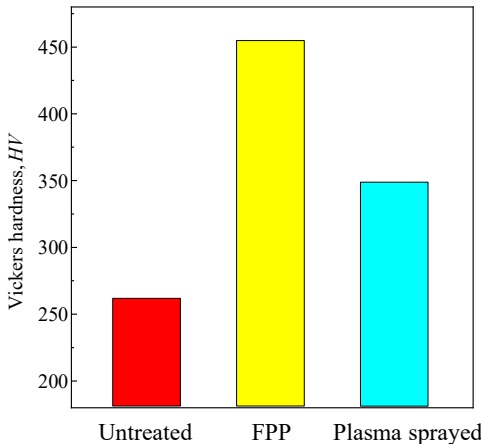
Figure 5: Vickers hardness of untreated, FPP treated and plasma sprayed specimens.

Fig. 5 shows the results of Vickers hardness measurement for each specimen. In the case of FPP treated and plasma sprayed specimen, the hardness of substrate beneath the HAp layer was measured. It was found that FPP increased the hardness of substrate. The hardness of plasma sprayed substrate was also improved due to alumina grit blasting before plasma spraying.

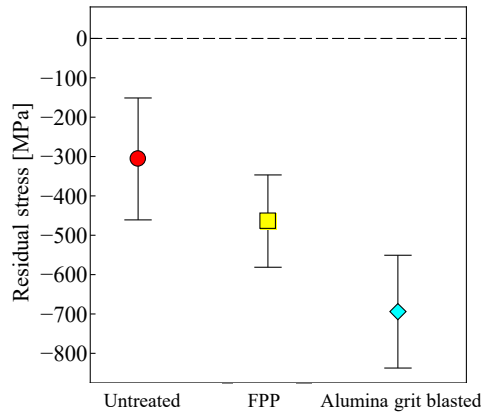
Figure 6: Residual stresses of untreated, FPP treated and alumina grit blasted specimens.

Fig. 6 shows the residual stress generated on the surfaces of the untreated, FPP treated and alumina grit blasted specimen. Compressive residual stress was increased at the surface of the FPP treated and alumina grit blasted specimens.

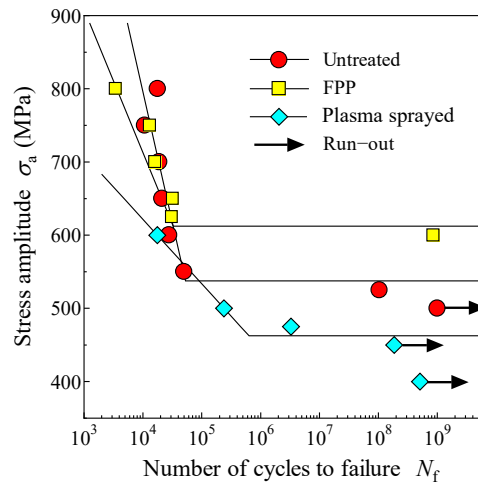
Figure 7:  $S$ - $N$  diagram.

Fig. 7 shows the  $S$ - $N$  curves for each specimen. Data points with arrow indicate the run-out specimen.  $S$ - $N$  curves of all types of specimen indicate fatigue limit. Based on this result,  $S$ - $N$  curves were determined by accepting the  $S$ - $N$  curve model with fatigue limit in the JSMS standard [8]. The fatigue limit of the untreated specimen was 538 MPa, while 613 MPa and 463 MPa for the FPP treated and plasma sprayed specimens, respectively. The FPP treated specimen exhibits the highest fatigue limit of all due to the significant increasing of hardness. In addition, the subsurface fracture was seen in the FPP treated specimen. Fig. 8 shows the SEM image of subsurface fracture surface. No defect (inclusion or defect) was found at crack initiation site. In the plasma sprayed specimen, it is clear that a significant deterioration of the fatigue strength was observed, compared to the untreated and the FPP treated specimens. Fig. 9 shows the SEM image of crack initiation site of the plasma sprayed specimen. In this case, a defect formed by alumina grit blasting was found at the crack initiation site, suggesting fatigue crack initiation from the defect.

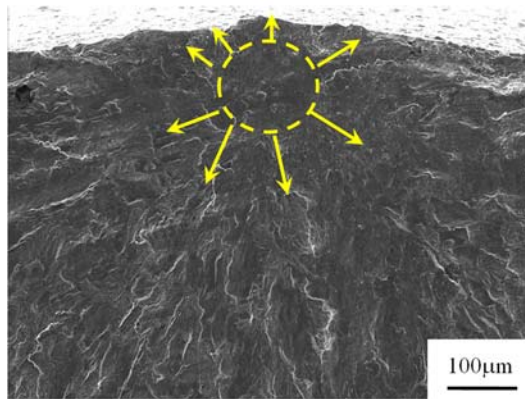
Figure 8: SEM image showing the FPP treated specimen fracture surface ( $\sigma_a=600$  MPa,  $N_f=8.5 \times 10^8$ ).

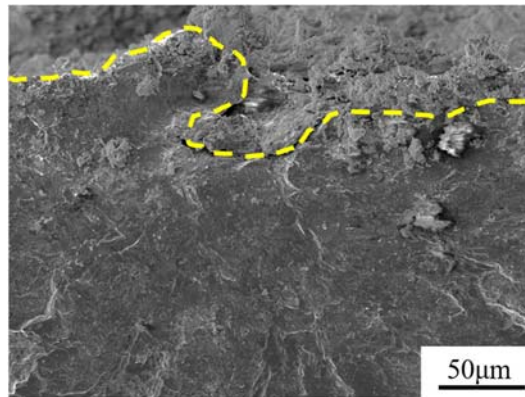
Figure 9: SEM image showing the plasma sprayed specimen fracture surface ( $\sigma_a=475$  MPa,  $N_f=3.3 \times 10^6$ ).
