MECHANICAL ANALYSIS OF A PIEZOELECTRIC SENSOR USED FOR DAMAGE DETECTION IN A STEEL STRUCTURE JOINT

NOBUHIRO SHIMOI, CARLOS CUADRA & HIDETO KANNO
Faculty of System Science and Technology, Akita Prefectural University, Japan

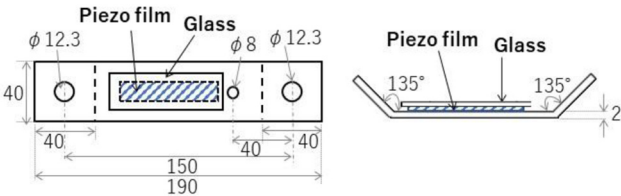
In this research, the developed sensor consists of a piezoelectric film that is placed on a steel plate and covered with a layer of glass, as shown in Fig. 1. A special glue is used to fix the glass. This glue is a silicone that requires the application of ultraviolet rays to harden.

Figure 1: Piezoelectric sensor systems.

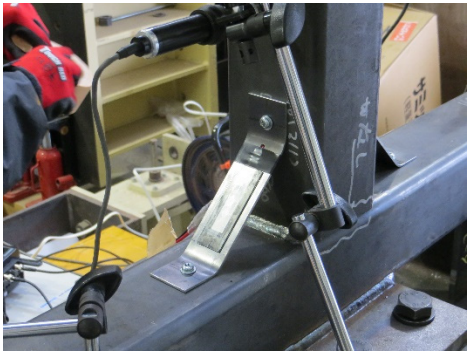
The steel base or plate of the sensor allows the detection system to be installed in a structural joint as can be seen in Fig. 2.

Figure 2: Sensor systems installed at beam-column joint.

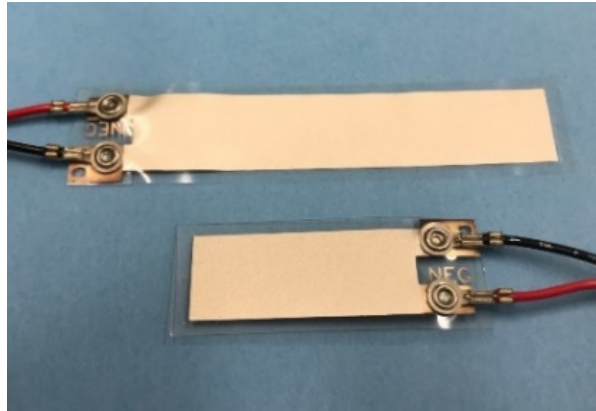
The proposed piezoelectric sensors use piezoelectric films. This film could be, for example, DT2-028K film (16 mm \times 73 mm) and LDT1-028K film (16 mm \times 73 mm) shown in Fig. 3. These are commercial multipurpose piezoelectric sensors to detect physical phenomena such as vibrations or impacts. The piezoelectric film element is laminated to a polyester sheet and produces a usable electrical signal output when forces are applied to the sensing area. The dual wire lead attached to the sensor allows easy connection to a monitoring circuit or device to process the signal.

Figure 3: Piezoelectric films.

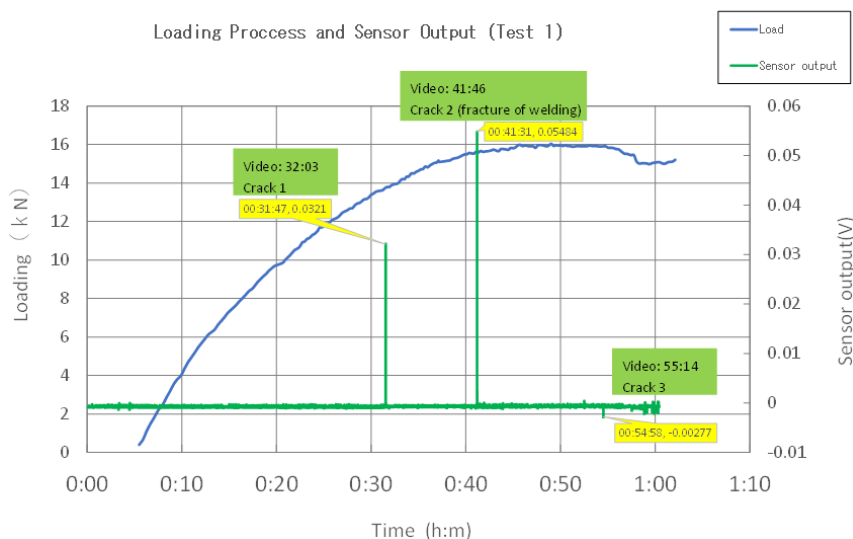
Monotonic lateral load was applied reaching a maximum load of the order of 16 kN and the maximum displacement was 35 mm which corresponds to a drift angle of 1/20. Results for load history and sensor response are shown in Fig. 5. Piezoelectric sensors show a first response at a drift angle of the order of 1/100 (Crack 1), and a second response is clearly observed at a drift angle of 1/50 (Crack 2). The drift angles at which piezoelectric sensors respond are relatively large. Therefore, it is necessary to improve the setup of sensors to obtain responses at early steps of loading. Although these preliminary results permit to verify the response of sensors for large deformation it can be concluded that it is possible to estimate the level of deformations using these simple piezoelectric sensors.

Figure 5: Test specimen and full-scale static test setup.

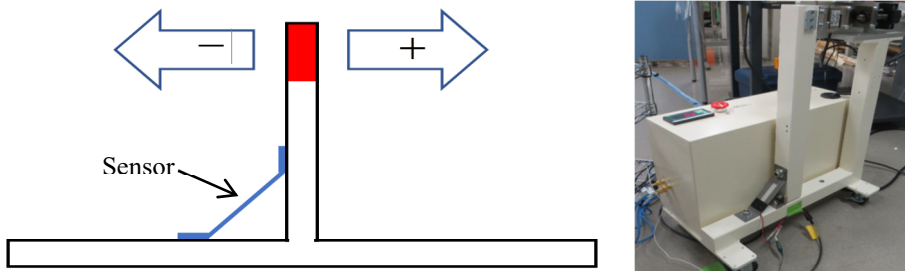
Full scale test to study the response of the piezoelectric sensor at the same time as the response of the structure is not an optimal procedure. Therefore, to study only the sensor response, an automated procedure was designed. This automated test allows studying the behaviour of the piezoelectric sensor system under different load conditions and allows a variation of the dimensions and shape of the sensor. The automated system shown in Fig. 6 is called as a Sally robot that consists of a horizontal beam and a vertical element connected by a pin joint with the horizontal element. The load is applied at the top of the vertical element by a screw system controlled from a computer and the load is measured by an electric load cell and the displacement stroke is measured by electrical transducers. For positive load as

shown in Fig. 6, the sensor is supposed to work in tension and for negative load direction, the sensor should work in compression.

Figure 6: Automatised test system (robot Sally).

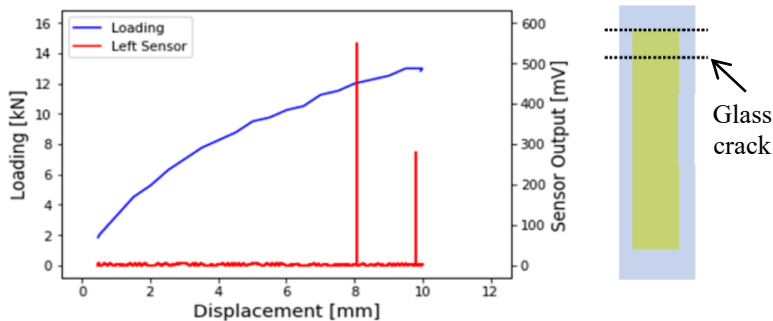
The results for loading in positive and negative direction are shown in Figs 7 and 8. The sensor response is plotted in red colour and the sensor reaction (or glass breakage) occurs at 8 mm and 10 mm for positive and negative directions respectively. This is a large level of displacement corresponding to a drift angle of 1/75 to 1/50, which are important values for structural deformations. Therefore, it is necessary to redesign the dimensions of the sensor system to obtain reactions to smaller deformations.

Figure 7: Results for loading in positive direction.

On the right side of Figs 7 and 8, the location of the glass cracking is indicated by dotted lines. It can be observed that in case of positive load (the sensor plate is supposed works in tension) the cracks are located at the upper part of the sensor plate and not at the central part as originally planned. In the case of negative load, the sensor plate works mainly in compression and the cracks are located in the central part of the plate. To ensure that cracks always occur in central part of the plate, it is necessary to decrease the cross section in the central part to induce a stress concentration in this part.

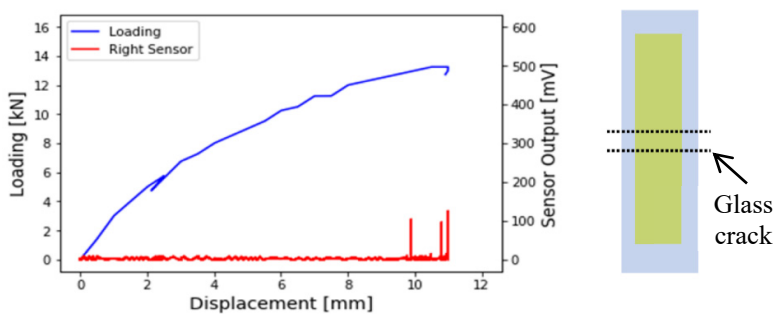
Figure 8: Results for loading in negative direction.

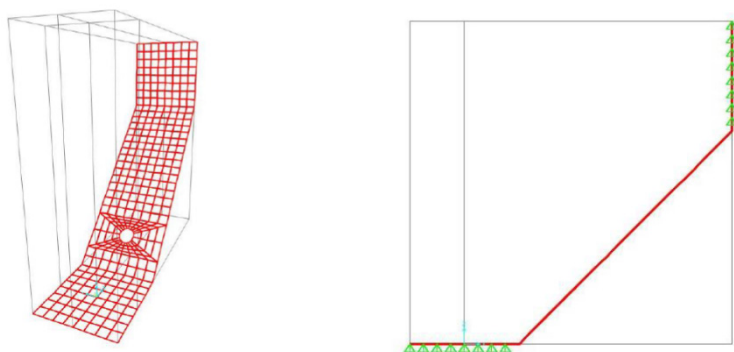
In case of automated tests, a finite element analysis is performed to investigate the stress distribution on the sensor plate due to both load patterns. The model of the sensor plate is shown in Fig. 9. Plane shell elements are use and it is also considered the hole that is used to pass the electric cables. The objective is also to investigate the effect of this hole in the stress distribution. Both ends of the plate are considered pinned joints. The sensor plate is fixed to the horizontal and vertical element by means of bolts and therefore it is considered a good approximation to model these boundaries as pinned joints. Then, deformation of the upper right part of the plate is applied as external action that causes the stress in the central plate.

Figure 9: Finite element model of sensor plate.

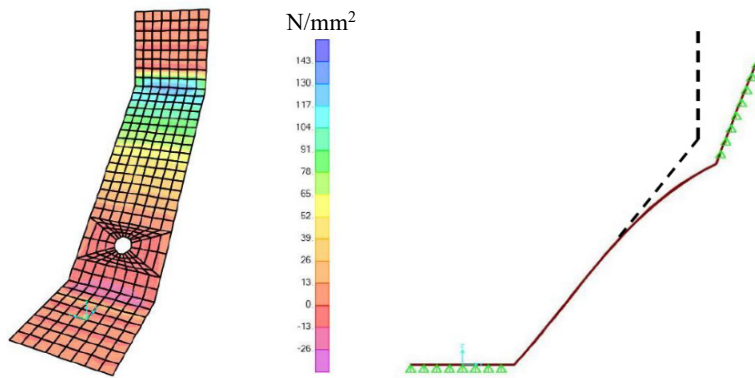
The distribution of stress and deformation due to positive load is shown in Fig. 10. Since the displacement with linear distribution is applied in the upper right part of the plate, this part rotates as a rigid body. The deformation shows that flexion due to bending moment is concentrated at upper part of the sensor plate. Therefore, this moment causes the stresses on the plate. The concentration of this stress (which is tensile stress) causes the cracking of glass at the upper part of the sensor.

Figure 10: Results for loading in positive direction.

From the analysis of both load cases, it was observed that the small hole in the plate does not significantly affect the stress distribution.

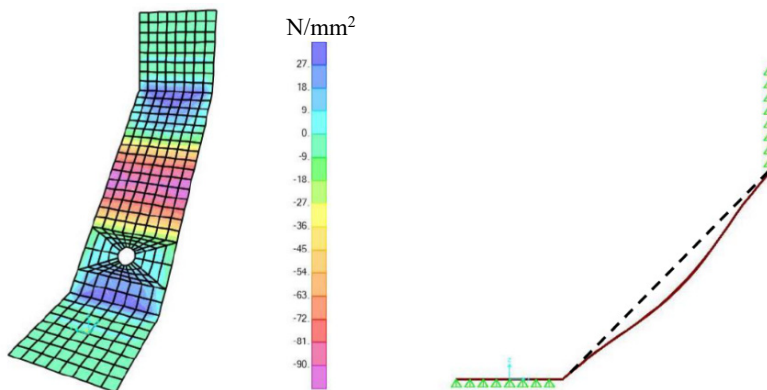
In case of negative load, compression stress is originated at upper part as is show in Fig. 11. However, in this case since a thin plate is subjected to compression stress, it is necessary to consider the effect of the buckling behaviour. The results considering the buckling effect are shown in Fig. 12 and it can be observed that the stresses are concentrated in the central part of the sensor. This stress is then believed to cause cracking of the glass in the central part of the plate.

Figure 12: Results for loading in negative direction and considering buckling effect.

The finite element analysis method was used to investigate the stress distribution affecting the sensor reaction and the location of the cracks in the part of the sensing glass. It was found that the steel base plate works in bending and the stresses originate by bending moment. In the case of compressive stresses, it was shown that it is important to consider the buckling effect.
