Change in surface states of ultrafine grained copper due to cyclic stresses

Abstract

High-cycle fatigue tests were carried out on smooth specimens of ultrafine grained copper produced by equal channel angular pressing for 8 passes. The change in surface states during stressing was monitored, showing that shear bands (SBs) were formed at an early stage of stressing. These SBs were oriented along one set of maximum shear planes which correspond to the shear plane of the final pressing. After the formation of SBs, the surface damage was slowly extended with further stressing, where a significant extension of the damaged areas occurred in the latter half of its fatigue life. Correspondingly, the surface hardness exhibited an initially moderate drop, which was closely followed by a more severe reduction in the latter half of the fatigue life. This initial drop in hardness was found to strongly depend on the decreased dislocation density caused by the dynamic recovery due to stressing, while the more severe reduction in hardness may be attributed to the grain coarsening: coarsened grains in the post-fatigued samples were observed by the transmission electron microscopy. In addition, th

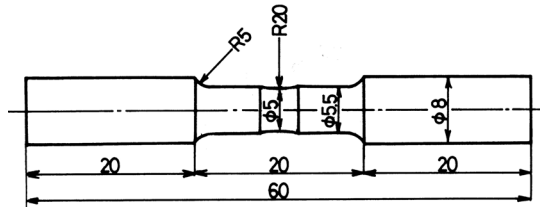
Five millimeter-diameter round bar specimens (Fig. 1) were machined from the processed bars. Each specimen had a shallow circumferential notch to localize damaged areas for successive observations of the surface. However, the fatigue strength reduction factor for this geometry was close to 1, so that each specimen can be considered as a plain specimen. All fatigue specimens were electrolytically polished (~ 25 µm from the surface layer) in order to remove any preparation affected surface layer. All tests were carried out at room temperature using a rotating bending fatigue machine operating at 50 Hz. Observations of fatigue damage on the specimen surface were performed using optical microscopy (OM) and scanning electron microscopy (SEM). The stress value referred to is that of the nominal stress amplitude, σ_a , at the minimum cross section.

Figure 1: Shape of the specimen.

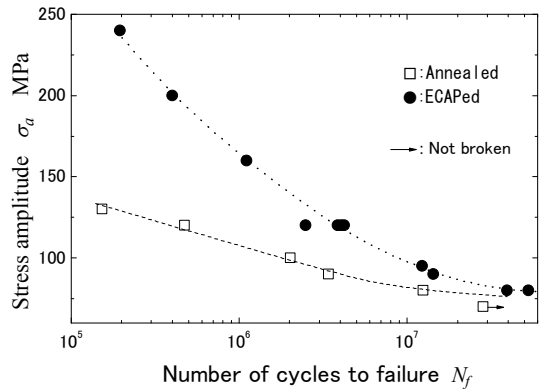
Figure 2 shows the S-N diagrams of fully annealed and ECAP-treated copper. For all UFG copper examined under stress controlled testing, the enhancement in fatigue life is obvious. The degree of enhancement is sharply increased with increasing stress amplitude. In the long-life field in excess of $N = 10^7$ cycles, however, the fatigue life to failure of UFG copper tends to coincide with that of fully annealed copper.

Figure 2: S-N curves.

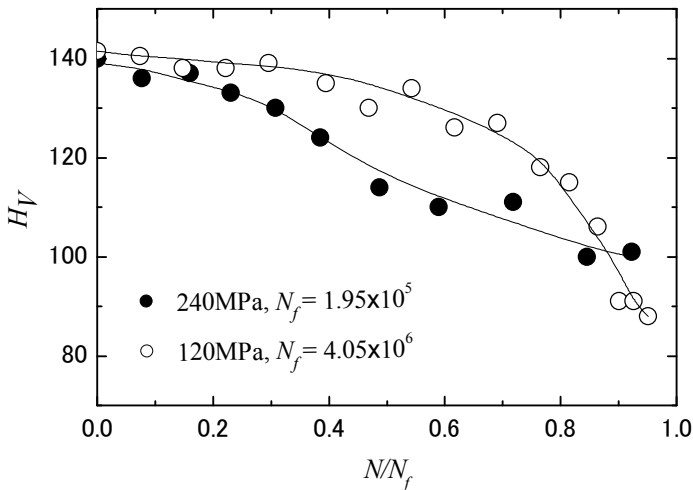
Figure 4 shows the change in surface Vickers hardness (load: 2.9 N) during repeated stressing of $\sigma_a = 120$ and 240 MPa. Here, each curve represents an average of the hardness measurements taken at six different locations. The maximum errors of the raw average hardness measurements were roughly within $\pm 10\%$. The surface hardnesses of post-fatigued specimens were 60–75% of as-ECAPed samples depending on the stress amplitudes. Regarding the decreasing trends, a surface hardness exhibited a moderate decrease in the first half of fatigue stages and a significant drop in the later stages.

Figure 4: Change in surface hardness during stressing at $\sigma_a = 120$ and 240 MPa.

There were different decreasing trends of the H_v vs. N/N_f relationship between the first and later fatigue stages (Fig. 4). The hardness in the first half of the fatigue stages showed a moderate reduction. It has been shown that the GBs in UFG copper are in highly non-equilibrium conditions and have high energies, where the absorption of dislocation into GBs takes place with remarkably enhanced diffusion [16]. The initial (gentle) drop in hardness appears to result mainly from a release of strain energy relating to a decrease in the dislocation density due to dynamic recovery. Regarding the dislocation density after fatigue,

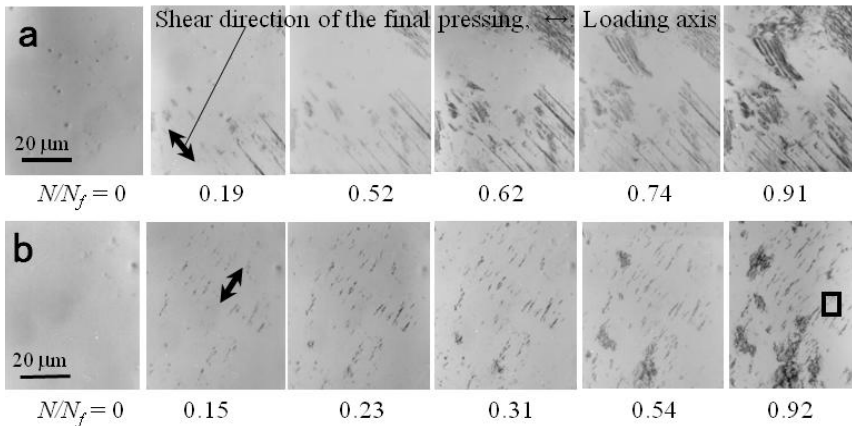
Figure 5 shows the formation process of surface damage for $\sigma_a = 120$ and 240 MPa, where the number of cycles to failure, N_f , for these specimens were $N_f = 4.05 \times 10^6$ and 1.95×10^5 , respectively. During the initial stages, SBs along the plane of maximum shear stress, which correspond to the shear direction of the final pressing, were initiated. It was found that there is a pronounced time lag in

the onset of a significant enlargement of the damaged areas [8]. For example, at $\sigma_a = 240$ MPa (Fig.5b), the number of SBs initiated at an extremely early stage of cycling (e.g., $N/N_f < 0.1$) increased as the number of cycles increased, followed by the saturation of the number of SBs after $N/N_f \div 0.2$. The length of SBs observed in the early fatigue stages ($N/N_f = 0.2$) did not increase after the subsequent stress cycling to the fracture of the specimen. Damaged areas with other morphological features started to initiate damage after $N/N_f = 0.3$, this damage continued to grow up to the fracture, bringing a significant enlargement of the damaged areas. In addition to this, the whole surface observations of these specimens indicated that the damaged regions were formed at an early stage of cycling, and that the number and area of these regions slowly increased with further cycling up to a specific number of cycles, depending on the stress amplitude. Once this specific number of cycles had been exceeded, both the number and area of the damaged regions showed a significant rise. The number of cycles performed for $\sigma_a = 120$ and 240 MPa prior to the start of this remarkably large extension in damaged regions was $N/N_f \approx 0.5$ and 0.3, respectively. By investigating the change in surface hardness and formation process of surface damage together, it was found that this considerably large drop in hardness in the latter half of the fatigue life is closely related to the significant formation of damaged areas.

Figure 5: Change in surface states during stressing: a $\sigma_a = 120$, $N_f = 4.05 \times 10^6$; b $\sigma_a = 240$ MPa, $N_f = 1.95 \times 10^5$.

Figure 6a shows SEM micrographs of the highlighted areas (squares) indicated in Fig. 5b. The protrusions in Fig. 6a are straight and approximately parallel to the shear plane of the final pressing (as indicated by the arrow). The morphology of the protrusions would place them into the PSB-like SB category [7]. The SEM micrograph in Fig. 6b shows the formation process of PSB-like SBs during repeated stressing. Stressing for $N = 7000$ cycles ($N/N_f = 0.036$) results in the formation of a $1\mu\text{m}$ -long intrusion along the shear direction of the

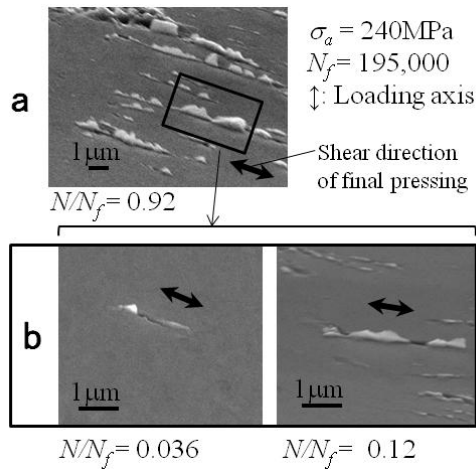
final pressing. The material could be forced to come out in the form of plate-like protrusions by way of intrusion. The formation processes of PSB-like SBs may be associated with a grain coarsening assisted by non-equilibrium states of microstructure with high energy, excess volume, and long-range stress fields. At $\sigma_a = 120$ MPa, the PSB-like SBs observed at $\sigma_a = 240$ MPa did not form, but line-like protrusions with 20 to 40 μm length were initiated [8]. A typical crack initiation site was PSB-like SBs and intrusions adjacent to the line-like protrusions.

Figure 6: SEM micrographs of a fatigued surface at $\sigma_a = 240$; a PSB-like SBs along the final pressing shear direction; b formation process of PSB-like SBs.

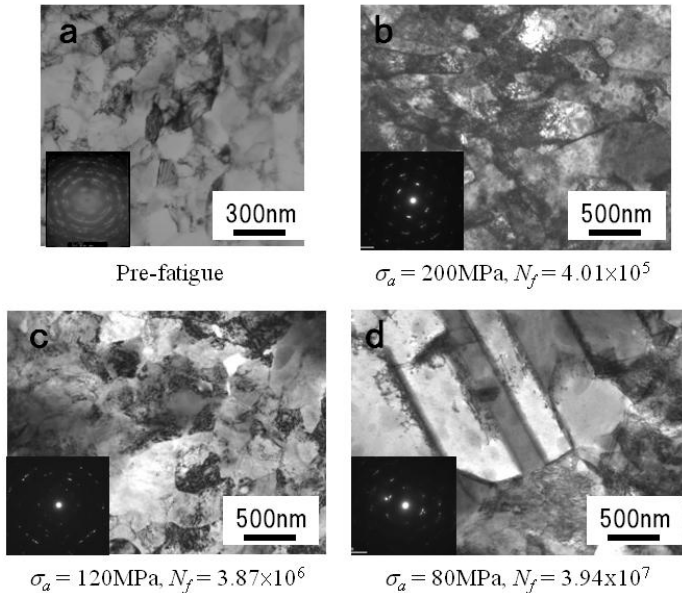
Figure 7 shows TEM micrographs of as-ECAPed (a) and post-fatigued samples (b, c, and d). The original ECAPed microstructure had granular grains with an average size of 300 nm. The grain coarsening occurred in the post-fatigued samples. Grain coarsening occurs by dynamic recrystallization [1, 2, 5]. Evidently, the fatigue time might be important in determining the coarsening of the microstructure. It has been suggested that a certain time and cumulative strain is required for the release of sufficient stored strain energy for the dislocation motion, recrystallization process, and subsequent grain coarsening to occur [5, 12, 14, 15].

Figure 7: TEM micrographs; (a) as-ECAPed sample; (b, c, d) coarse grains observed in post-fatigued specimens.

In the latter half of the fatigue life, all samples exhibited damaged regions that rapidly extended, with a large, simultaneous drop in surface hardness. Höppel et al. [5] conducted tension-compression fatigue tests on UFG copper to investigate the parameters governing cyclic softening and microstructural coarsening during cyclic deformation. They showed that pronounced grain coarsening is related to a marked cyclic softening in strain-controlled tests, but in the regime of low stress amplitudes in stress-controlled tests, only weak cyclic grain coarsening occurs. Mughrabi and Höppel [14] recently reviewed the fatigue properties of very fine-grained materials, and noted that, while SBs have been observed in UFG copper of different purity grades after fatigue in both strain- and stress-controls, grain coarsening was essentially only observed after strain-controlled fatigue. In the present stress-controlled tests, despite the very low applied stress amplitude ($\sigma_a = 80\text{ MPa}$: about 18% of tensile strength), coarsened grains embedded within the original fine grain/cell regions were generated after 3.94×10^7 repetitions (Fig. 7d). Thus, it can be concluded that the significant drop in later stages

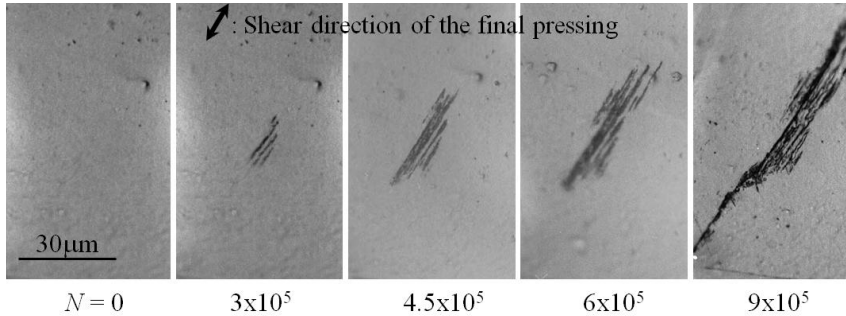
Figure 8 shows the growth behaviour of an initial crack at $\sigma_a = 120$ MPa. After initiation, the crack tends to propagate along the shear direction of the final pressing.

Figure 8: The growth behavior of an initial crack at $\sigma_a = 120$ MPa ($N_f = 2.50 \times 10^6$).

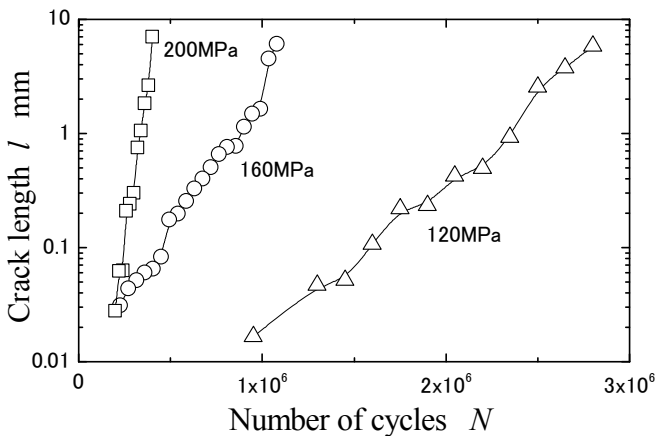
Figure 9 shows the crack growth curve ($\ln l$ vs. N). The crack growth life from an initial size (e.g. $20 \mu\text{m}$) to fracture accounted for about 60-80% of the fatigue life. The growth curves were approximated by linear relations, meaning that the crack growth rate is proportional to the crack length.

Figure 9: The crack growth curves.

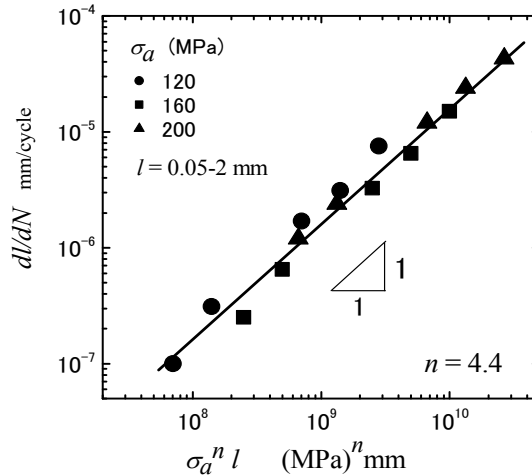
It is generally accepted that the crack growth rate of a small crack in conventional grain sized materials cannot be determined by the linear elastic fracture mechanics approach. In such cases, a term $\sigma_a^n l$ can evaluate the growth rate of small cracks. Here, n is the material constant. Figure 10 shows the growth

data of a small crack; dl/dN vs. $\sigma_a^n l$ relation [18, 19]. The value of n was 4.4. Here, the term dl/dN indicates the growth rate of major cracks calculated from the growth curves represented by smooth curves which pass through the mean average of each set of plots, rather than from the raw growth data. The growth rate of small cracks of UFG copper was estimated by $\sigma_a^n l$.

Figure 10: Crack growth data (dl/dN vs. $\sigma_a^n l$ relation).
