Studies of microscopic strains on Alloy 600 surfaces arising from stress corrosion cracking

Abstract

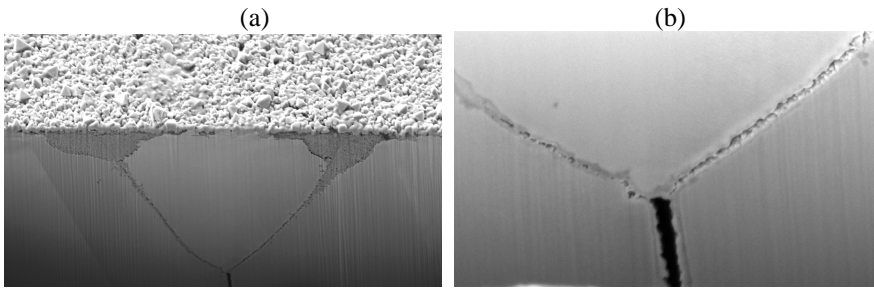
Figure 1: SEM images of grain boundary structure along the apex of the outside diameter of the C ring (a) lateral view of a FIB cut revealing the oxide metal interface. (b) detail of the triple point shown in the lower part of (a).

The apex of the outside tube diameter proved to have a significant fraction of grain boundaries that appeared to be beveled due to enhanced oxidation. The sub-surface structure of such boundaries was explored using a FIB to cut a cross section (see Figure 1). A lateral 3 kV SEM image of a FIB cut is shown in Figure 1(a), revealing the oxide metal interface, the beveled grain boundary/surface interfaces and detail of the surface oxide. A crack pathway can be seen in the oxide surface, as well as through the compact oxide in the bevel and along the boundary.

It appears that the enhanced oxidation resulted in crack propagation that extended through the compact oxide in the bevels, the oxide crystals on the outer surface and into the grain boundaries below the bevels. This appears to be good circumstantial evidence for the initiation of cracking from the expansive growth of oxides within the bevels.

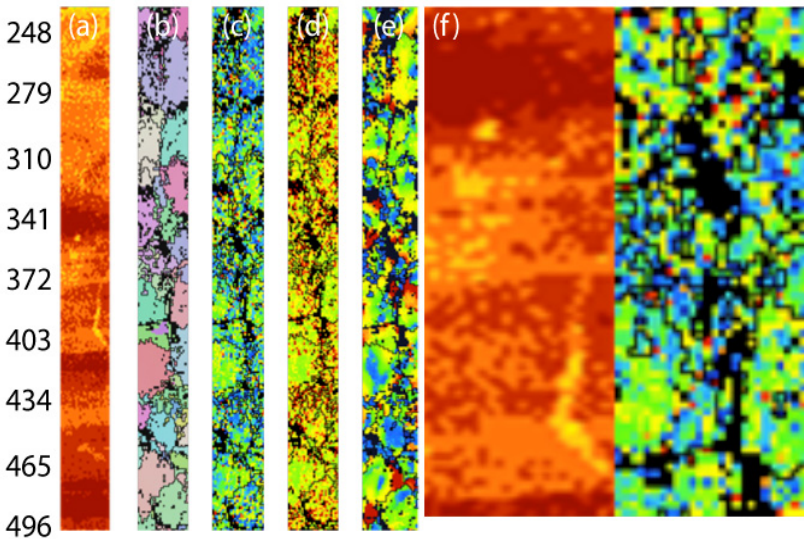
Figure 2: Laue diffraction maps of a narrow portion of the apex of the outside diameter of the C ring. (a) absorbed x ray image (b) crystallographic orientation image with grain boundaries outlined by black lines (c) y elastic strain tensor image (d) composite elastic strain image (e) absolute mis-orientation image (f) expanded view of absorbed x ray map and y strain tensor map.

However, an overlap between a physical crack and the PXM map was made possible from the use of imaging x ray absorption measurements as outlined in a previous publication [7]. Figure 2 shows maps of the imaging x ray image along with those of orientation, Y strain tensor, composite strain and absolute mis-orientation. In Figure 2(a) the light streaks are ascribed to near surface cracks.

By comparing the locus of this discontinuity with the orientation map (Figure 2(b)), it appears that the crack is aligned with the boundary between two grains. A line of boundaries continue up the centre of the map and along this line a number of pixels cannot be indexed, suggesting significant disruption of the crystal structure along this line, some of which must be due to plastic strain caused by the cracking. The map of y tensor strain (Figure 2(c)) shows an accumulation of compressive elastic strain in the narrow band in grains to the left of the boundary and lying close to it. Figure 2(e) shows the distributions of mis-orientation near the crack region. Compared to the y tensor elastic strain map there is little evidence of correlation between the crack locus and incidence of plastic strain as measured by absolute mis-orientation.

A magnification in Figure 2(f) of the presumed crack locus and the strain pattern shows that most of the compressive elastic strain is found within several microns to one side of the crack. This pattern is also observed in the composite strain map (Figure 2(d)) but not as clearly-defined as in the y tensor map. The compressive elastic strain intensity reaches a maximum of $\sim 5 \times 10^{-3}$ within a few microns of the crack itself. The immediate region of the crack has a low crystal order as diffraction patterns there cannot be indexed and appear as black in the Figure.

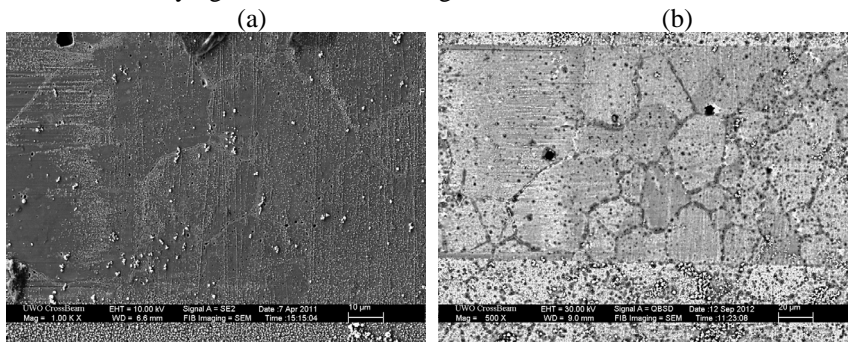
Figure 3: SEM plan view images of the surface of the corrosion flat after the (a) second treatment (secondary electron display) and (b) third electrochemical treatment (backscattered electron display).

electrochemical treatment. SEM images of the surfaces are shown in Figure 3 after the second and third treatments. After the third treatment bevelling of the grain boundaries became extensive (Figure 3(b)) and cracks even became apparent in the oxide within the FIB pre-treated area under higher resolution. The differences between the area pre-treated by FIB and that untreated area are apparent with much greater growth of micron-scale crystallites in the untreated area. A crack opening near a grain boundary is shown in Figure 4(a) and cracks were also found to be present among the oxide crystallites outside the FIB area. FIB sectioning was then used to create a cross-section of the oxide and underlying metal in the vicinity of the crack and this is shown in Figure 4(b). The oxide shows internal cracking as well as an extension of the crack into the grain boundary in the underlying alloy. One possibility is that expansion of the oxide because of its Pilling-Bedworth factor could have led to an initiation of a crack in the boundary. The surface oxide was depth profiled using Auger Electron Spectroscopy and was determined to be about 80% nickel oxide/20% chromium oxide. The structure of the oxides would be expected to be NiO and Cr_2O_3 based on the solution pH and temperatures used in the autoclave [14].

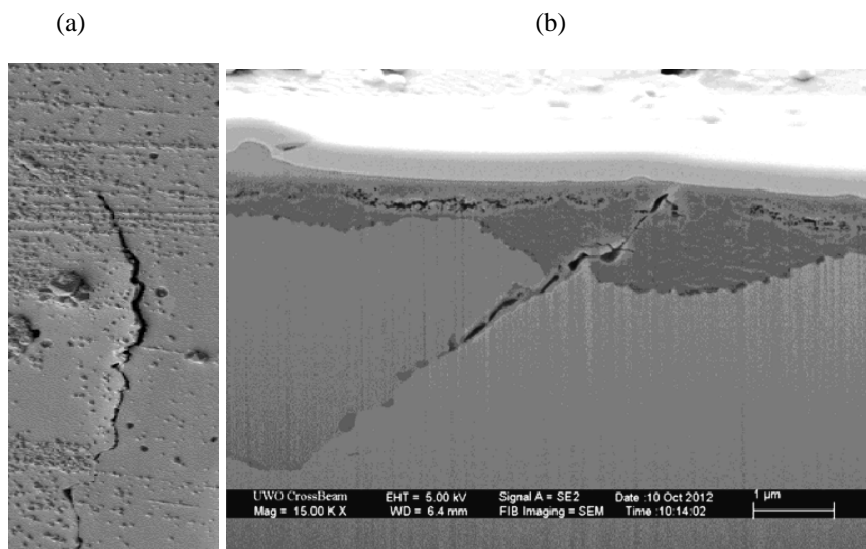
Figure 4: SEM images of a crack in the surface oxide following the third electrochemical exposure (a) plan view back scattered electron image of the crack within the FIB pre-treated area (b) secondary electron image of a FIB cross section of the same crack.

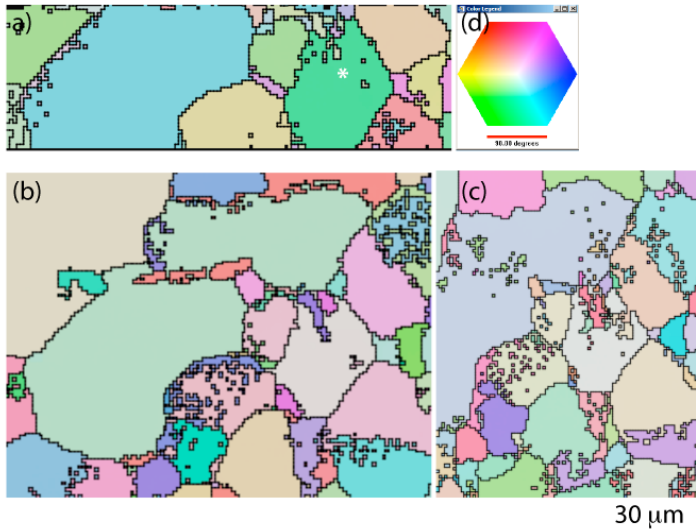
Figure 5: Crystallographic orientation maps for the same area on the polished Alloy 600 flat following: (a) 6h (b) 12h and (c) 24h of electrochemical exposure (see text).

The above studies took place within the small area on the flat that had been analysed on three successive occasions by PXM (after each electrochemical treatment). The Laue diffraction maps of crystallographic orientation in the same proximate areas are shown in Figure 5. The colours shown represent crystallographic poles whose angular relationship is shown in (d). The black

lines represent changes in angular orientation of >5 degrees. The pole figure for individual grain faces changes between exposures because the sample orientation with respect to the x ray beam has changed somewhat with each analysis. The length scales are only approximately the same. A correct scale bar is shown for (c). The same grain shapes can be recognised in these maps as well as in Figure 3. These maps represent information from an average of several microns into the surface. The overall shape of most of the grains did not change throughout the treatment; however, there was the notable addition of small phases along many grain boundaries. Their exact origin is not understood but it is believed that they are associated with the growth of oxide phases at or near the grain boundaries.
