# **Difficulties in the design for conservation of archaeological remains: the G1 temple in My Son**

L. Binda, P. Taranto & P. Condoleo

*Department of Structural Engineering, Politecnico di Milano, Italy*

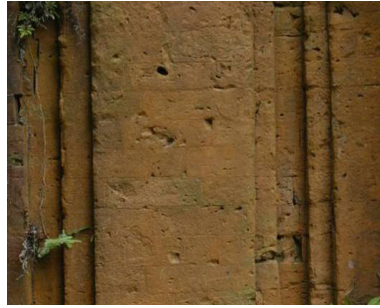
Figure 2: The thin joints between the bricks.

In the case of the My Son temples, even the peculiar technique of construction using brick masonry with joints made by a natural resin created problems in the material characterisation (fig.2).

The masonry in elevation is composed by three leaves (fig.6a). The two external leaves have a thickness equal to the brick length, and consist of entire bricks with very thin (micrometric) joints of natural resin. Both horizontally and vertically the bricks are so tightly bonded that joints are hardly visible. It is worth remarking that this technique enhances the protection of the walls from the biological attack of the vegetation, as long as the joints are not damaged.

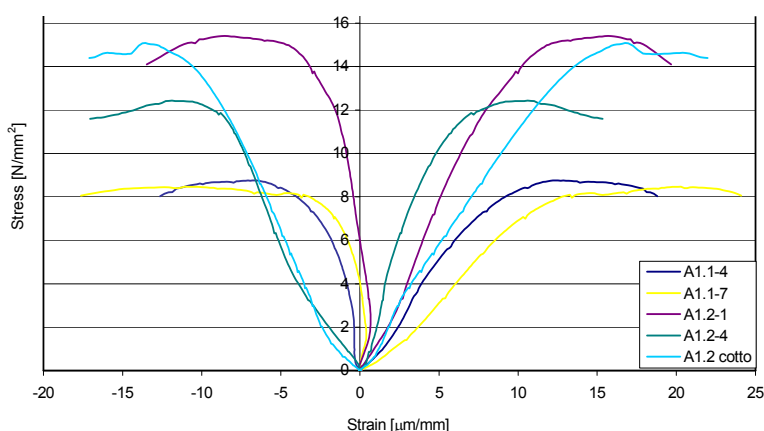
Figure 4: Brick – compression test on cubes (40x40x40 mm).

Compression tests were carried out on cubes (40x40x40mm). Once again all the values were very much scattered, between 8 and 14 N/mm<sup>2</sup> (fig. 4).

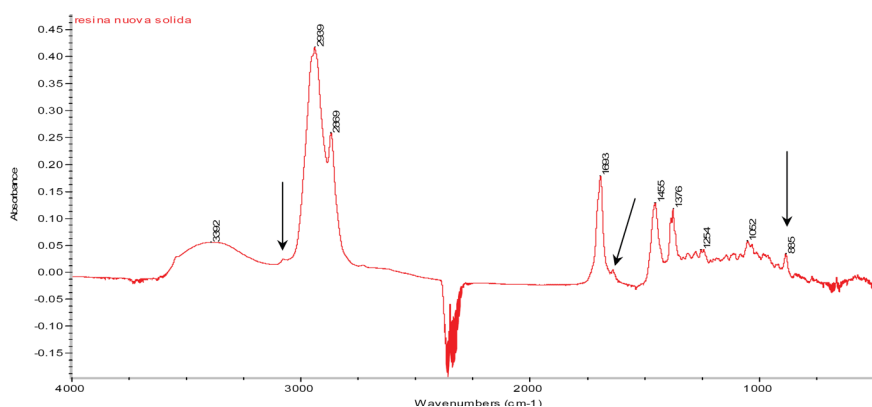
Figure 5: FT-IR spectrum of the solid residue after evaporation.

The material extracted with solvent from the joints was analysed and found to contain organic matter, the highest percentage being *dammarenediol*, also found in RES1. Spectroscopic analysis of different materials was also carried out (fig.5). The infrared spectrum of the non-volatile fraction of the commercial RES1 is very similar, but not identical, to the infrared spectrum of the organic fraction from the joints of the bricks. The differences indicate the existence of longchain alkyl residues as well a modification of the carbonyl group in the molecules. The observed spectral changes could be associated with chemical change due to oxidative processes which might have occurred in the joints over the centuries [3, 4].

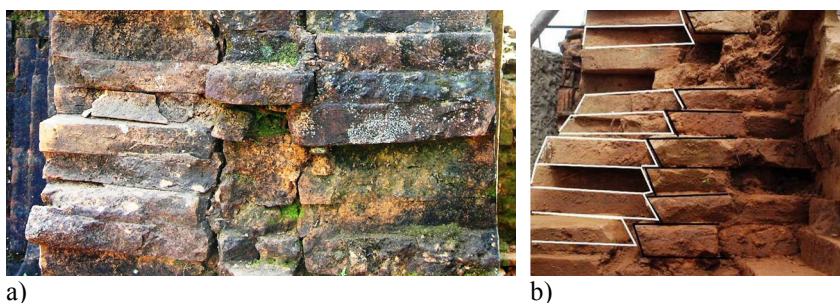
Figure 6: a) Vertical section of the wall of the principal body of G1; b) toothing between the external and the internal leaf.

The external leaf consists of horizontal and continuous layers of headers. Only in few cases stretchers are found, to provide some toothing between the leaves (fig.6b).

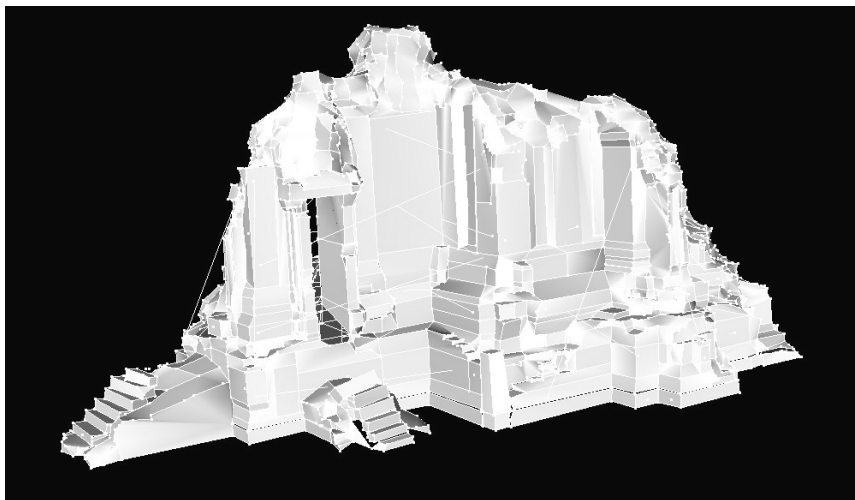
Figure 7: 3D model of the kalan G1 – south-west side view.

For the photogrammetric description of the geometry use was made of a commercial software (PhotoModeler Scanner, Eos Systems). The model was generated by acquiring the positions of over 5200 points identified by means of 27 photographs taken along radial directions, the average number of points per photograph amounting to 447. Critical points were identified on a large number of pictures (even more than 5) [6].

Once the geometry of the structure had been reproduced by the photogrammetry survey program, the model was converted to AutoCAD drawing for further elaboration. In this context, some details, whose consideration would not have been possible or precise in the photogrammetric survey, were implemented. The obtained model is suitable for import in structural analysis codes (fig.7).
