Transformation of Ishak Pasha Palace

B. Yıldırım

Abstract

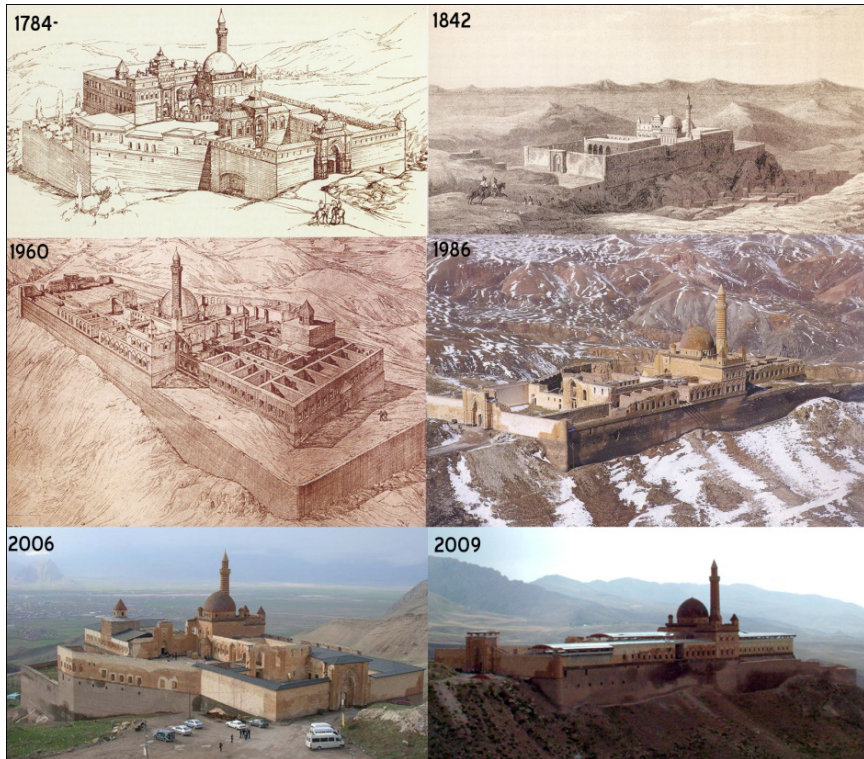
Figure 3: Transformation of Ishak Pasha Palace through the years, 1784 [4] reconstruction of the palace (drawing by M. Akok), 1842 [11], 1960 [4], 1986 [4], 2006 [20, 21].

The first survey study was carried out by Mahmut Akok who was assigned by the newly established Survey Bureau of General Directorate of Monuments and Museums in 1956 [4]. After the survey prepared by Akok, the cleaning and restoration of the ruined parts of the Palace were started between 1960 and 1961. Those interventions that were carried out without detailed examination and excavations were for repair and conservation purposes [9]. Small-scale restoration work continued until 1984 when the palace has become the object of attention with a paper, Gündoğdu presented in the Symposium of National Palaces, mentioning the importance and necessity of a more comprehensive restoration project [18]. Not until 1992 The Ministry of Culture has taken action and the first comprehensive restoration project of the Palace has initiated by Kaba Construction Firm.

upon the completion of restoration project, unwanted interventions and applications by the Contractor Firm since 1992 were pulled down and the restoration was initiated. First of all, the walls that were repaired by the concrete mortar were pulled down and rebuilt using lime mortar [9]. Except for the ones of Harem part, all the walls were restored with cut stones [18].
