# Learning from historic wooden structures: performance through hurricanes, earthquakes and other challenges in the tropics

## Abstract

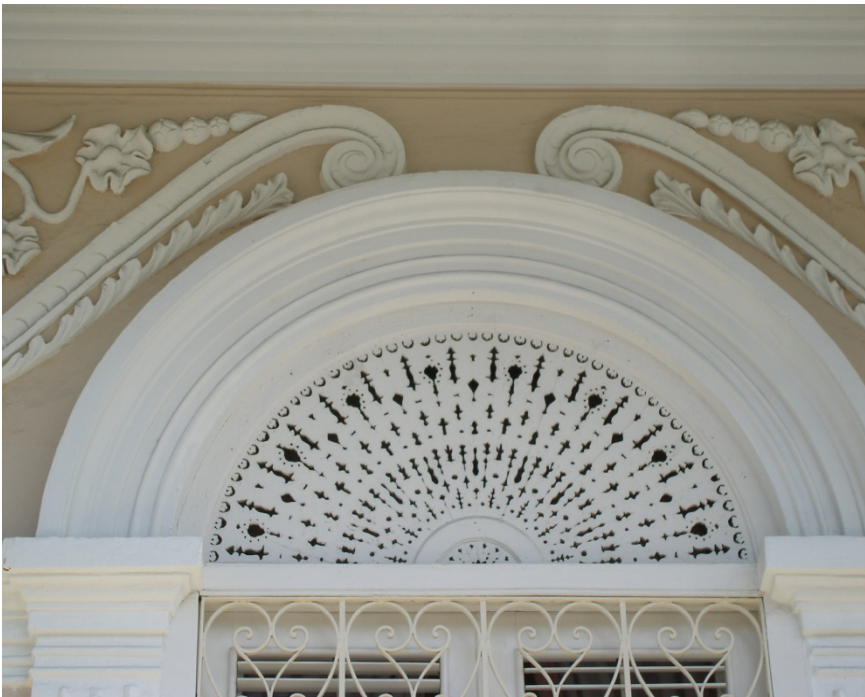
Figure 1: “Montantes”, “Soles Truncos” or transoms. Picture by D. Luna.

The original materials and methods of construction in wooden historic structures that are still standing through the island and are naturally adapted to tropical climate should be documented. Every component of the structure was designed and built for a purpose. At the same time that efficiency was important; beauty and detail were relevant to human occupation and social status. The natural interior lighting prevails in many ways through particular elements such as “montantes” or transoms, fig. 1.

ventilation. Special holes over windows and doors called “soles trancos” or “montantes” were located to help the cross ventilation.

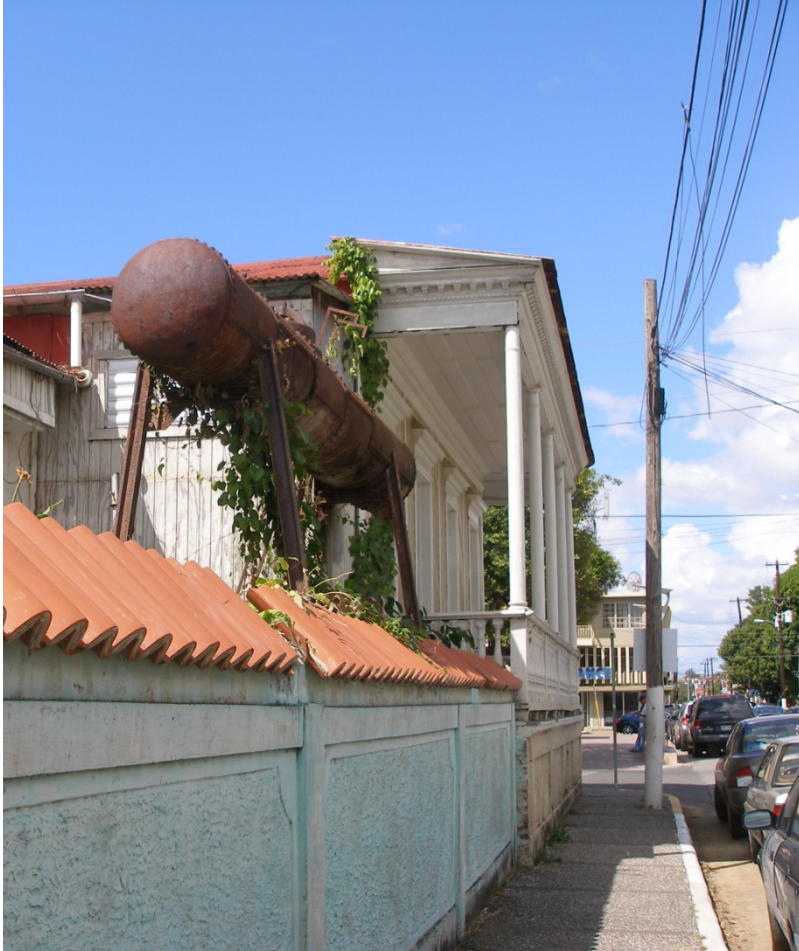
Figure 2: Water metal cistern. Picture by D. Luna.

The “Criollo” houses were sustainable in terms of water and energy. Water was collected from the roof through a channel system that directed it to the cistern, fig. 2. The cistern was the deposit for all the water used in the house including the garden. The cistern usually had a filter in order to make the water suitable for drinking. The cistern was located in the backyard close to the kitchen and bathroom and usually was an independent structure. On some houses the cistern was elevated and distributed the water to the bathrooms and kitchen directly after filtering.

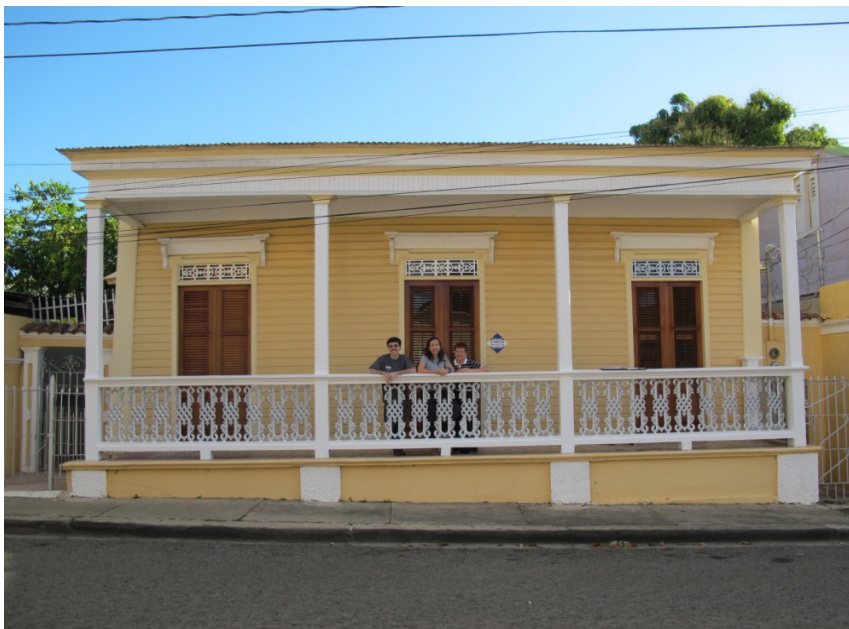
Figure 3: Casa Luna, picture by D. Luna.

Casa Luna has all the characteristic of a “Criollo Vernacular” house in Puerto Rico. It has a balcony along the north façade that face the street, fig. 3. The living room is centered in the main structure with two private rooms at each side. The gallery is an open hallway that connects the main living room with the kitchen, bathroom, and the rest of the house. At one side of the gallery is the patio. The structure is raised 24 inches from the ground in order to let cross ventilation underneath and ventilate the wood floors.

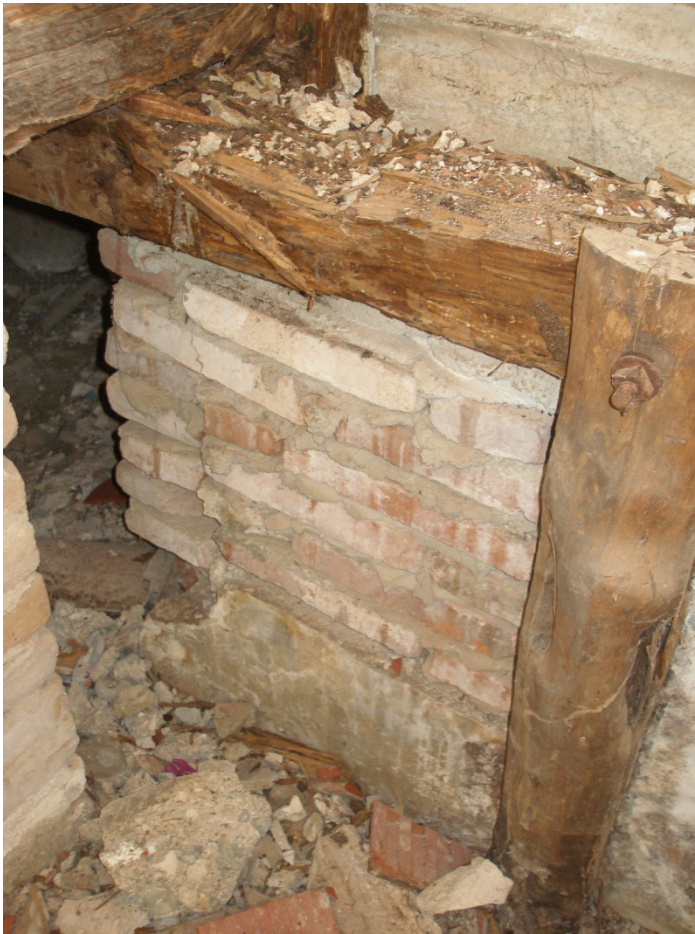
Figure 4: Tree trunk foundation. Picture by D. Luna.

From the foundations that were tree trunks inserted in the tamped soil, joints with the beams that supported the interior floor were inserted in the wood, fig. 4. The beams blocked the movement of the columns in two directions.

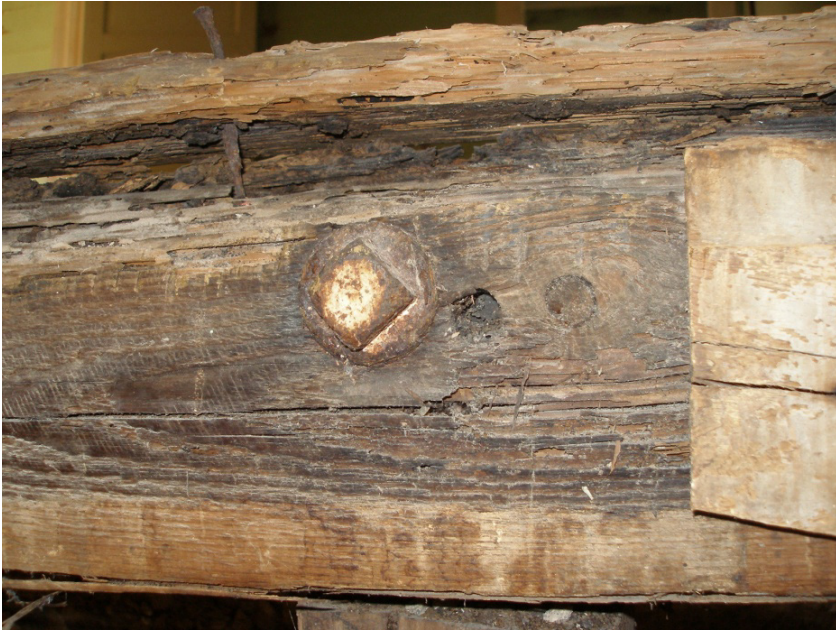
Figure 5: Joint. Wood with old screw. Picture by D. Luna.

At the top of the walls, the beams for the roof were supported by the columns distributed to the body of the building. These columns did not make it directly to the ground or foundations which make the structure flexible for some movement. The structure of the roof was made of individual trusses. All the joints through the whole structure were the same, wood inside wood, sometimes with screws, fig. 5. Other joints were wood lying over wood.

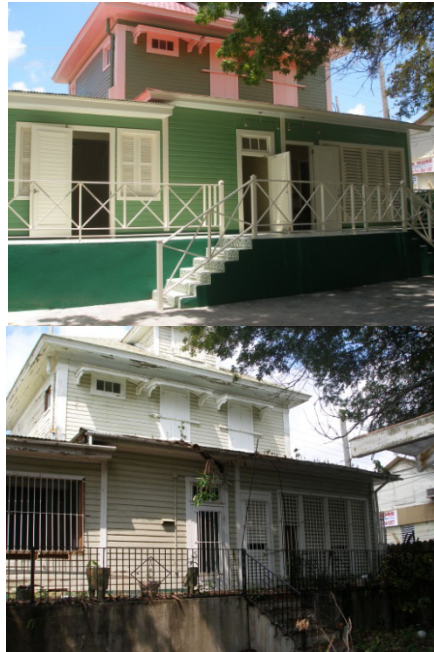
Figure 6: Actual and previous condition of a wooden historic structure. Picture by D. Luna.
