Preliminary results of landslide characteristics due to rainfall in the city of Ensenada, Baja California, Mexico using physical modelling

Abstract

The overall objective of this project is to produce maps identifying potential landslide hazard areas in the city of Ensenada, Baja California Mexico. In this paper we present the results of the granulometric analysis for 7 soil samples of different sites in the city that are subject to landslide or rock displacement hazard. We also present the tests done on the physical sliding model and a comparison between the sites and the model observations. The results show some consistency between the sliding model and the field observations.

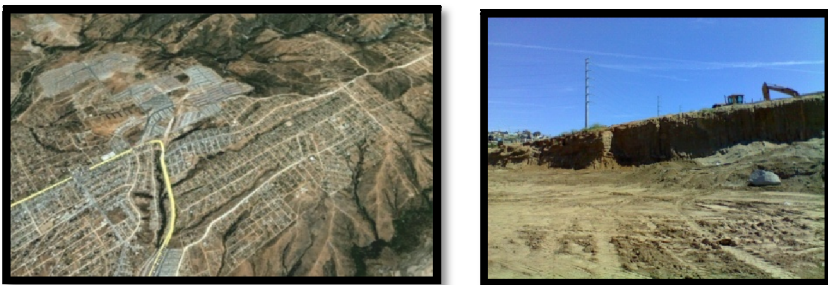
The first site is “Colonia 89” (Figure 2), a new housing development in which deep excavations are leaving steep slopes with risk of tear off by the weight of the overhead traffic.

Figure 2: Colonia 89 new housing development.

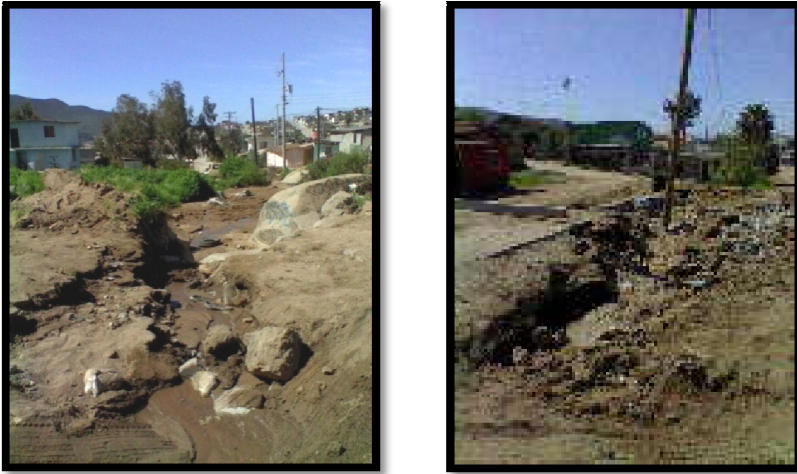
The second site selected is “Colonia Morelos I”. In this neighbourhood, we observed irregular settlements embodied on the hillside; if it continues to grow with no regulation, access to the homes will become almost impossible. At this location, the Terrazas El Gallo Hill and Colonia Morelos Hill converge forming a stream mouth towards the main street of the neighbourhood. City planners must consider debris and silt flow as well as mudslides (Figure 3).

Figure 3: Colonia Morelos I. One can observe the electricity pole in the middle of a stream bed.

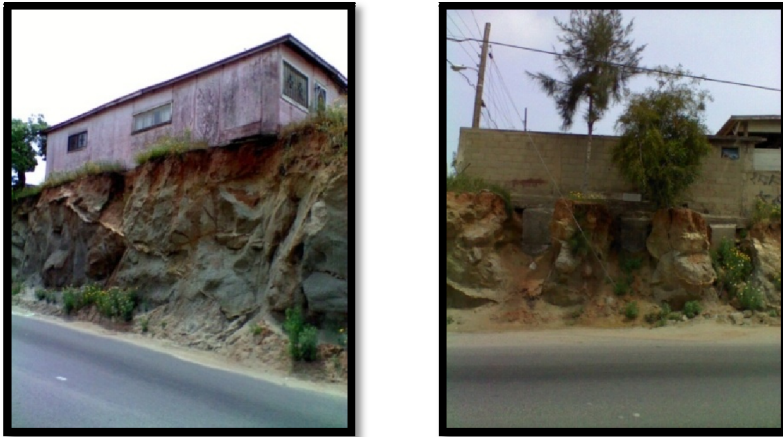
Figure 4: Two houses adjoining the Esmeralda Beltway. Note part of the bottom of the houses with no support.

Our third selection is near the Esmeralda Beltway between Delante and Diamante Avenues. In order to make the relief road, heavy machinery and explosives were used, leaving some houses and buildings with high risk of falling (Figure 4). At this location, when it rains, big chunks of granite rocks fall into the Beltway, leaving the structures vulnerable without their natural support in which they were built. It also represents a hazard for drivers using the road.

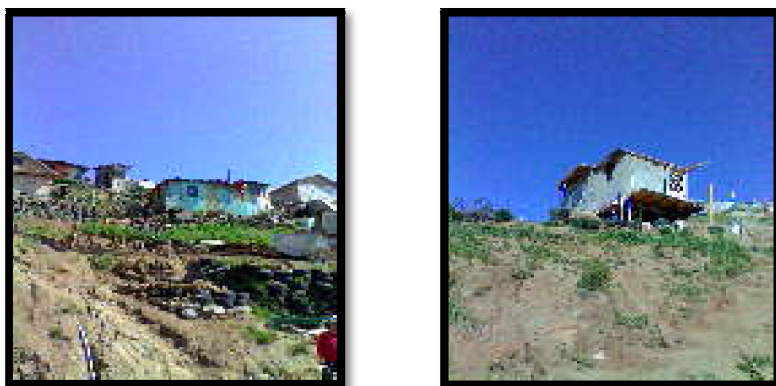
The Land Invasion called “Terrazas el Gallo” is not officially defined as a neighbourhood. Its houses are built on a steep hill (Figure 5). City planners have proposed that another Beltway for the city must be built in this section, so people who have taken over the land must be relocated, and this will lower the risk for this part of Ensenada.

Figure 5: Houses built on the “Terrazas El Gallo” land invasion.

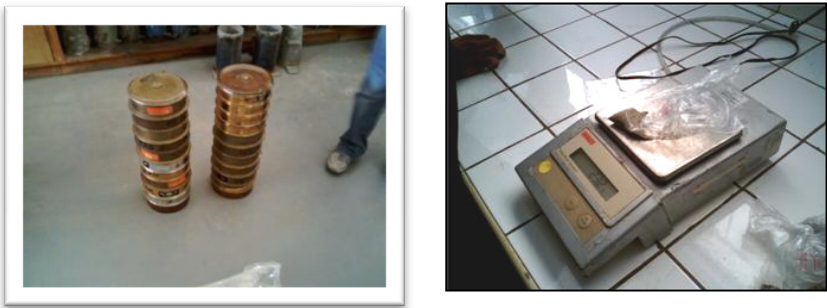
Grain size distribution was obtained as a first distinguishing property. The procedure used was a system of sieves with different mesh sizes, shaking the assembly of sieves by hand and obtaining the grain size diagram (Figure 7).

Figure 7: Soil testing: grain size distribution and weight.

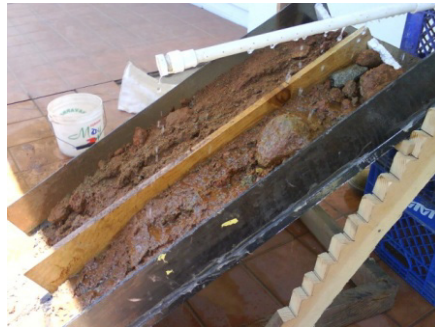
Table 1 shows that sand predominates in the soils of the Neighbourhoods studied. This explains the visible erosion and the sliding tendencies as a result of the destabilization by the housing developments (some illegally built on the slope of the hills), and the cuts made for the construction of roads. At “Praderas Del Ciprés” a Neighbourhood of recent creation, we found rocks and clay type material (Figure 8), making it a high risk location for landslides and rockslides, when it rains.

Figure 8: Testing the soil of Praderas del Cipres.

Tests done on the slab model reproduced coincides with the types of cracks found on the terrain studied. In particular, at “Praderas del Ciprés”, we found that clay material makes the rocks slide faster than the rocks collected from the “Beltway” subject to the model.
