Erbil Citadel restoration: some thoughts on earth-built constructions exposed to seismic action

J. A. Martin-Caro & I. Paniagua
INES Ingenieros, Spain

This paper will highlight the different studies for restoration work undertaken, paying special attention to the assessment of the structural performance of eight buildings of earthen construction under seismic action.

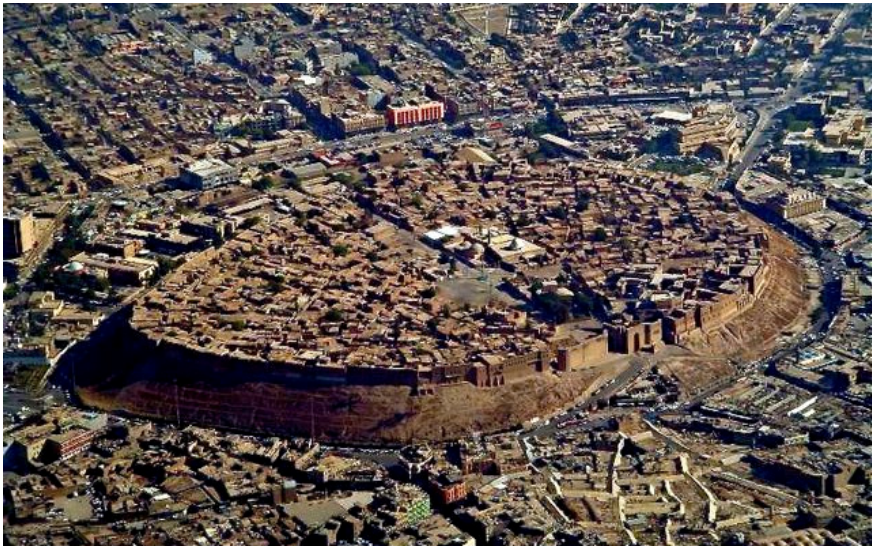
Figure 1: Aerial photo of the Citadel in 2012 [2].

The historic city of Erbil consists of a circular mound of 30 metres high, covering a surface area of nearly 150,000 m² and embankments between 35° and 45° (known archaeologically as *Tells*); the result of the accumulation of historical remains. This artificial elevation of incalculable archaeological wealth is topped by a Citadel, (Qelay or Qala't, meaning castle or Citadel), housing 322 groups of buildings, several palaces, four mosques and baths which date from the eighteenth century up to the present day.

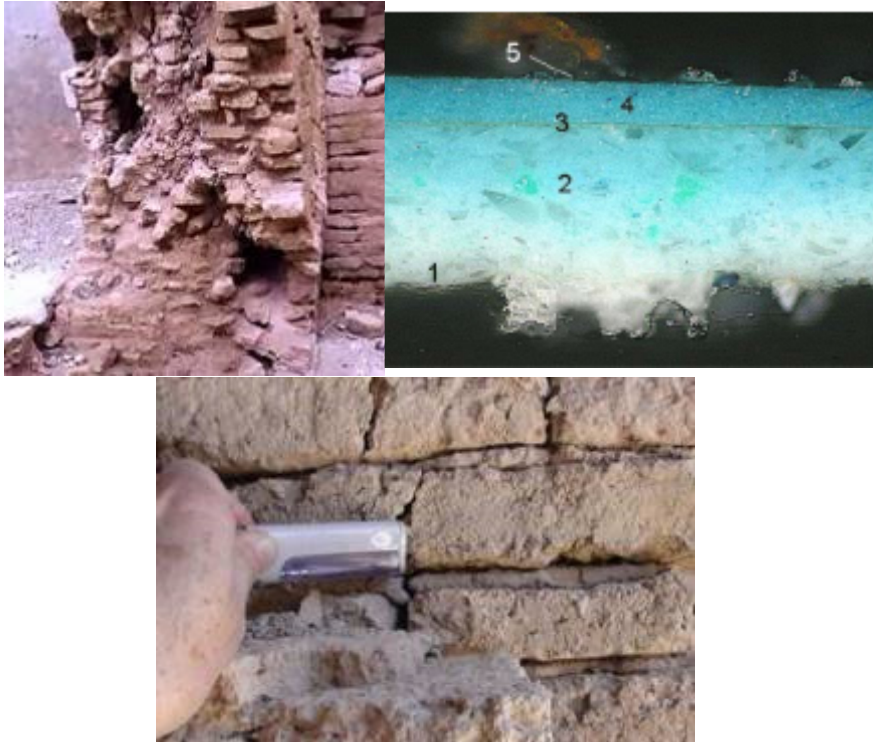
Figure 3: Photographs of different group 1 and 8 materials and photograph of a microscopic analysis to identify polychrome.

- Walls. Consist of rows of solid bricks, arranged in wall pattern (with varying degrees of firing) on both sides, with no connection between alignments. The space that confines the brick panels (30 to 100 cm thick) is filled with adobe, pieces of brick and fragments of rock (of varying compaction).

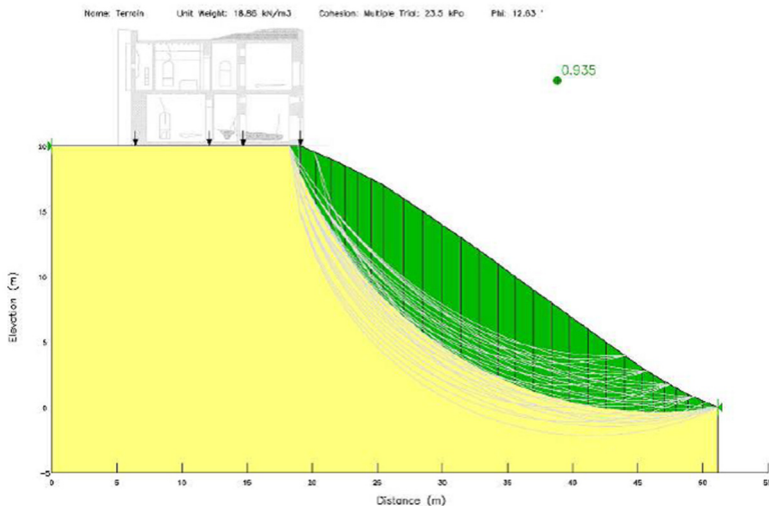
Figure 5: Study of the stability of the embankment in situations where the building is located on the edge. Safety factor 1.

In buildings that were on the edge of the embankment, it was enough on the one hand, to protect the embankment to prevent erosion caused by water and, on the other hand, lighten the load on the facade near the edge of the embankment, and tie the front foundations up with the rest of the building.

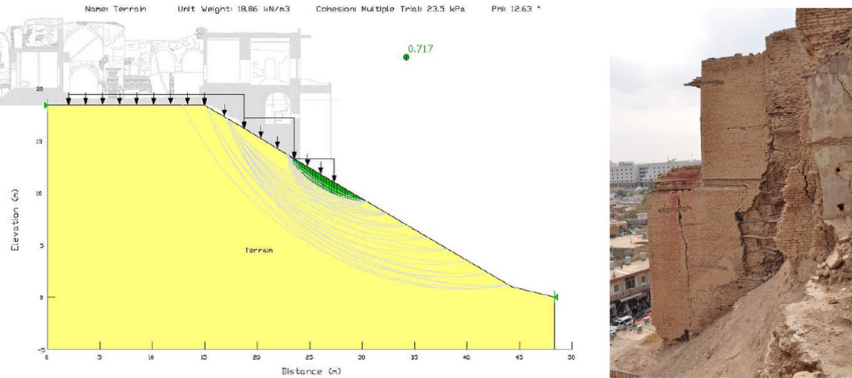
Figure 6: Study of the stability of the embankment in situations where the building is located within the confines of the embankment. Safety factor 0.7.

Therefore, in these cases we studied the possibility of inserting a deep-seated underpinning line (with micropiles) on the front which would serve, on the one hand, to take vertical loads down to deeper strata, relieving the load completely

from the embankment and, moreover, producing an anchor by slightly prestressing the micropiles/anchors, which would serve to pre-compress possible slippage circles. As this project could be potentially dangerous, since it could alter the internal construction of the *Tell*, it was agreed on a case-by-case basis with UNESCO and was only used in very special cases.

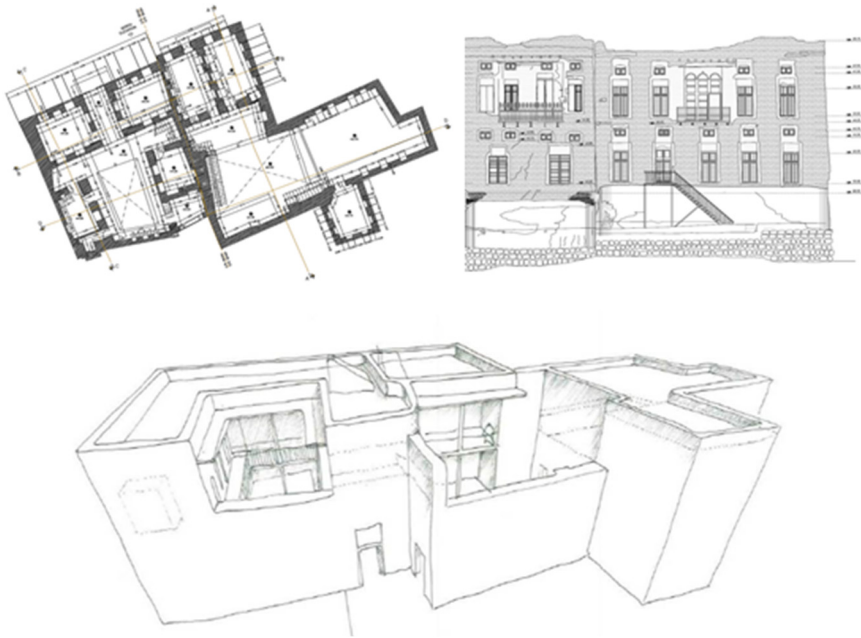
Figure 7: On flooring, elevations and 3D simulations of one of the buildings, the lack of symmetry can be seen.

Floors were not symmetrical, not even on one axis: each building complex was made up of courtyards and annexes with different heights, without there being any consistent approach. In addition, extensions over time were identified where construction detail had not been observed; the walls had not been worked in their joints: the thickness, bonding and constitution of each wall was different (affecting local and overall rigidity), etc.

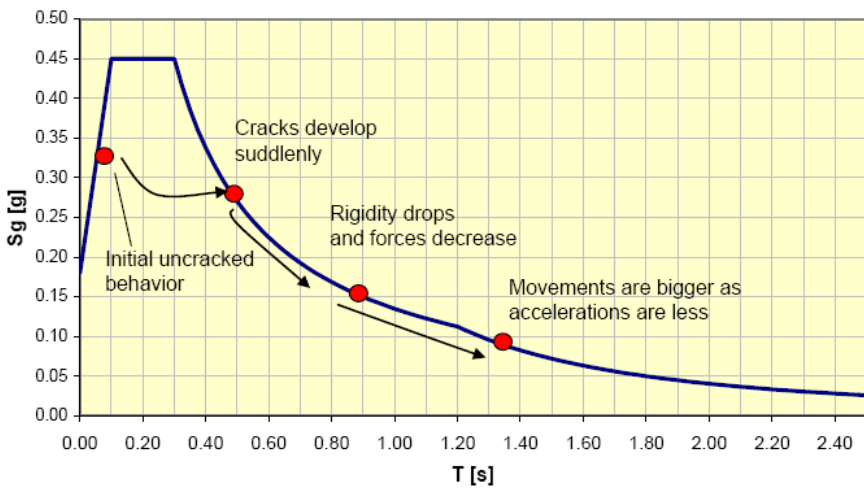
Figure 8: Outline of the seismic approach adopted in the design of the reinforcement.

Jointly with UNESCO, it was agreed to accept the possibility of introducing new materials into the constructions, for which reason eventually wooden beams were prescribed at the tops of the walls, as a rigid framework to bind together the various different walls which, in turn, were connected with the continuous foundation by vertical elements. These vertical elements of fiberglass were housed

in the interior filler of standard walls (sandwich with no strapping elements) and were anchored in the foundation and the upper wooden frame.
