Investigation of rail defects using an ultrasonic inspection method: a case study of Aksaray-Airport Light Rail Transit Line in Istanbul

H. Yilmaz & Z. Öztürk

Department of Civil Engineering, Istanbul Technical University, Turkey

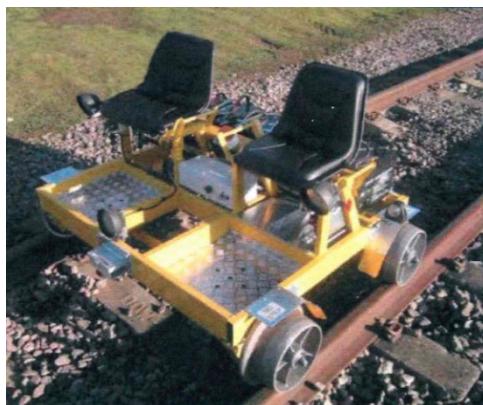
In this work, defective rails on Aksaray-Airport Light Rail Transit Line were identified by an ultrasonic inspection car operating at an average speed of 5 km/h. Ultrasonic inspection car involved 6 ultrasonic probes for per rail, thus 12 probes in total carried out the inspection process. In Figure 1, the ultrasonic inspection car is shown.

Figure 1: Ultrasonic inspection car.

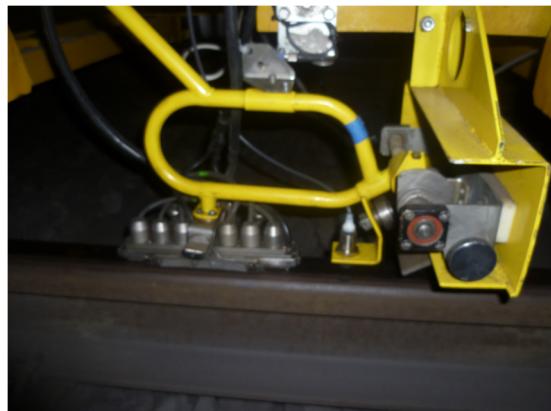
Both rails on the track were inspected simultaneously by the ultrasonic probes having a frequency of 2.5 MHz. Ultrasonic probes were capable of checking the rail head, rail web and rail foot for the flaws. Figure 2 presents the ultrasonic probes within the ultrasonic test car.

Figure 2: Ultrasonic probes within the inspection car.

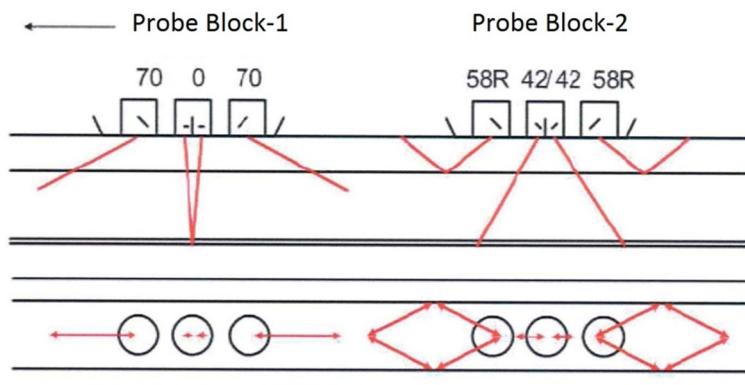
In order to increase the probability of detection of defects located in different parts of the rail, ultrasonic waves were transmitted into the rail at various incident angles. According to user manual of the inspection car, angles of the probes were 0° , 42° , 58° and 70° [11]. 0° probe and 42° probe performed the ultrasonic test throughout the rail section including rail head, web and foot. On the other hand, 58° probe and 70° probe inspected only rail head. Ultrasonic measurement of rails was conducted by 2 probe blocks and each of the blocks was composed of 3 ultrasonic probes (as shown in Figure 3).

Figure 3: Schematic representation of ultrasonic probes.
