BASIS FOR RELIABILITY ASSESSMENT OF INDUSTRIAL HERITAGE BUILDINGS AND A CASE STUDY OF A 19TH CENTURY FACTORY

J. MARKOVA, M. HOLICKY, K. JUNG & M. SYKORA

Klokner Institute, Czech Technical University in Prague, Czech Republic.

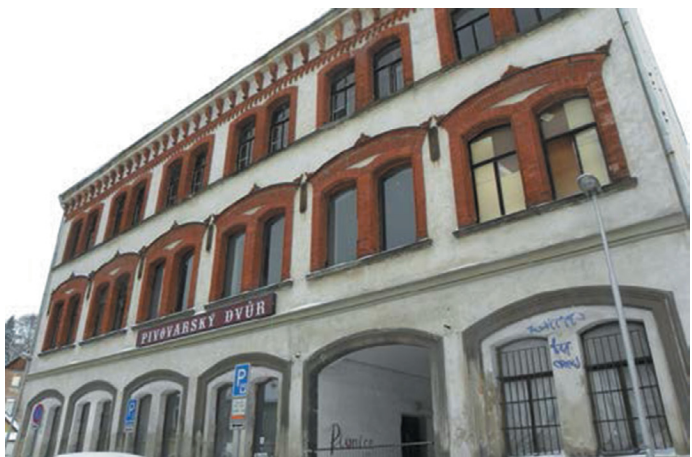
Figure 1: View of the former spinning factory.

had not been used and had gradually deteriorated for several years before the reliability assessment was carried out. Recently, it has been decided to recognize its heritage value, list the building as a regional monument and carry out its rehabilitation. The building with an ornamental façade before rehabilitation is shown in Fig. 1.

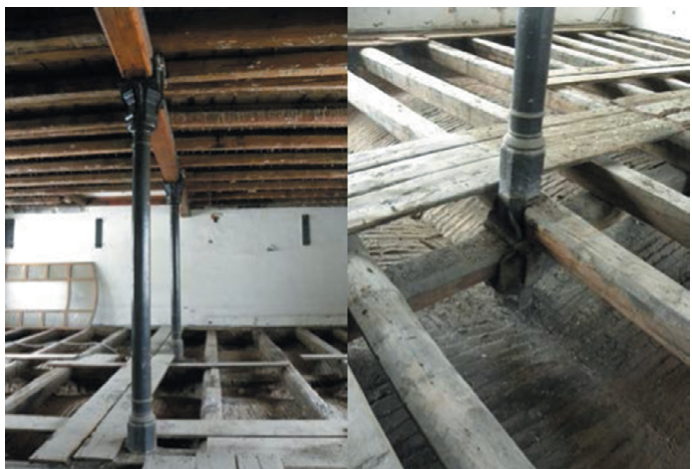
Figure 2: The load-bearing structure with cast-iron columns.

The building, made of fired solid bricks, consists of three timber floors supported by cast-iron columns with ornamental heads (Fig. 2), carrying timber beams and timber floors. The wood has been locally attacked by insects or dry rot.

Visual inspection revealed that masonry walls and cast-iron columns were without any significant damage affecting structural reliability. The geometry of all the cast-iron columns, including their thickness, was measured at heights of 1 and 2 m above the floor level. The average values for selected columns are given in Table 3.

Actual thickness of all the columns varies along height and is unexpectedly reduced for all the columns in the second floor. It should be noted that it was very difficult to obtain reliable information about actual geometrical imperfections of the columns.
