Learning from experience: creating sustainable urban greenspaces from brownfield sites

G. Sellers, T. R. Hutchings & A. J. Moffat

Environmental and Human Science Division, Forest Research, UK

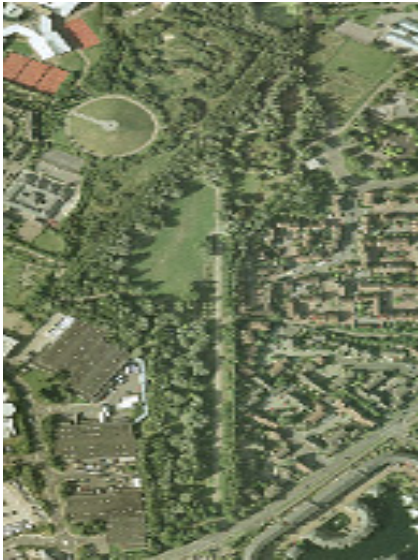
Figure 1: Aerial photograph of Russia Dock Park.

Russia Dock is located in Southwark and is part of the Surrey Docks redevelopment that was begun by the LDDC in the late 1970s. It is a linear greenspace development of around 20 ha, (fig. 1), which was formerly the Grand Surrey Inner Docks [3]. Some of the park is densely wooded with trees planted in the late 1970s and early 1980s to a 'naturalistic' landscape design. The main species were fast growing trees such as alder, willow and poplar, supplemented with more recent plantings of slower growing climax trees such as oak and beech. Other parts of the park open out into grass areas and the main paths follow the old wharf edges. Most of the dock was filled in but some was left to form water features, such as ponds, with interconnecting water ducts and streams. Water levels and flow were maintained by a complex water pumping

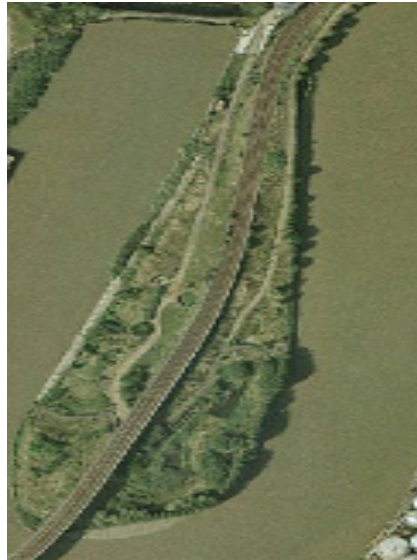
Figure 2: Aerial photograph of Bow Creek Park.

Bow Creek, a former railway yard, fig 2, was developed in 1996 when it was named the Limmo Peninsular Ecology Park. There were contaminated soils on the site but these were covered by a 200 mm layer of imported topsoil in 1991 as part of the development of the Docklands Light Railway (DLR) flyover, which bisects the park. Later reports commissioned by the LDDC [6] suggested that the land on the west side of the flyover could contain slightly elevated levels of mercury, so an extra 400 mm of topsoil was added there during park construction. The park was created with six small ecosystems which were designed as an educational tool for local schools and groups as well as being a valuable, if small, piece of greenspace in an area where it is lacking.
