Flexural retrofitting of reinforced concrete bridge pier type cross-sections with carbon fiber reinforcing plastics

G. C. Manos & V. Kourtides

*Laboratory of Strength of Materials and Structures,
Department of Civil Engineering, Aristotle University,
Thessaloniki, Greece*

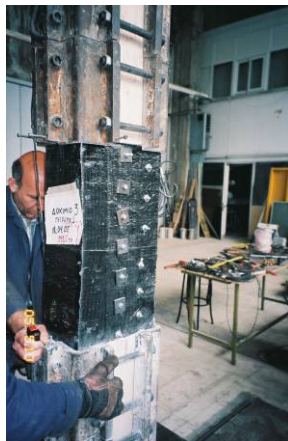
Figure 4: Confining steel brackets and partial CFRP confinement at the mid-part.

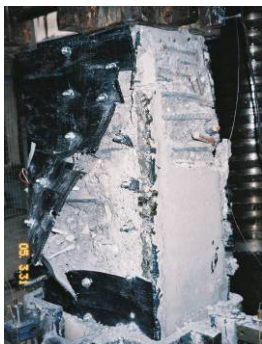
Figure 9: Failure of anchor bolts. Low effectiveness of partial confinement.

The failed virgin specimen without the partial confinement is shown in figure 6 whereas figure 8 and 9 depicts the failure of the anchor bolts for the “low effectiveness” partial confinement. In figure 11 the observed behaviour of specimen 4 test 1 is depicted. This was a virgin specimen with 5 CFRP layers partial confinement. In this case, a certain alteration was applied in the anchor bolts, by increasing their length. However, this was not sufficient to improve accordingly the effectiveness of the partial confinement, which was again linked to the failure of the anchor bolts.

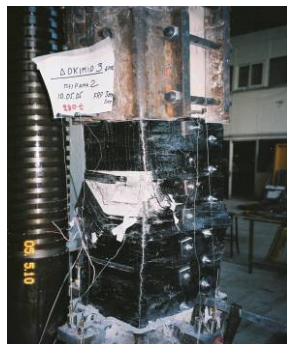
Figure 10: Tensile failure of CFRP layers. Considerable effectiveness of partial confinement.

relatively successful. The limit state for this specimen commenced with the tensile failure of the CFRP layers at the central zone and was accompanied, as expected, by a consequent compressive failure of the neighbouring weak part of the section. This is depicted in figure 10 where the anchor bolts, which were left intact, are also shown. As mentioned in section 3.1, the comparison in figure 11 is extended to include specimen 4 (Test 1), in which the partial confinement exhibited low effectiveness due to the failure of the anchor bolts.
