## Seismic response and torsional effects of RC structure with irregular plant and variations in diaphragms, designed with Venezuelan codes

### Abstract

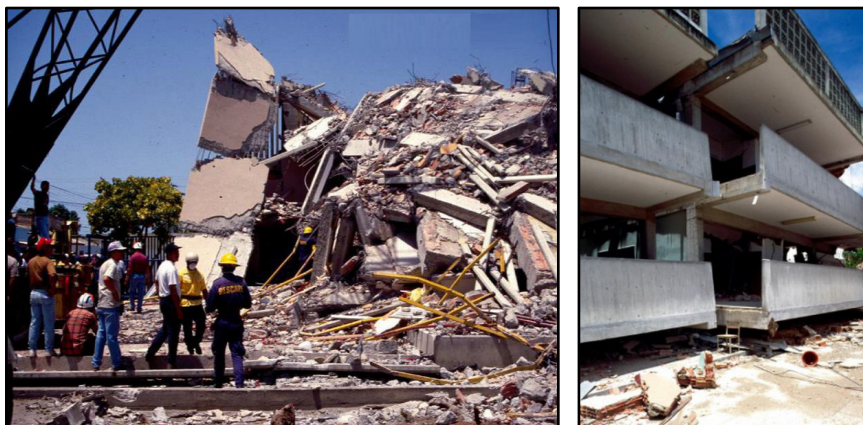
Figure 1: Buildings collapsed during the earthquake of Cariaco (1997).

In Venezuela, a few destructive seismic events have produced severe damages to a significant number of reinforced concrete framed buildings whose plants were characterized predominantly by irregularities like flexible diaphragms, structural discontinuities or L or H shapes, among others. These characteristics contributed in a decisive way to the collapse of buildings designed and built according to old versions of Venezuelan construction and seismic codes. Buildings with high torsional risk and discontinuity in diaphragms collapsed during the earthquake of Cariaco, Venezuela (1997), as it was the case of a commercial building and a school building collapsed during this earthquake (see Figure 1).
