# EVALUATION OF RESTORATION PROJECTS FOR THRONE VILLAGES' PALACES AND FORTRESSES

HAYA S. NASEREDDIN, ILHAM S. NASEREDDIN & GHASSAN J. DWEIK

Department of Civil Engineering and Architecture, Palestine Polytechnic University, Palestine

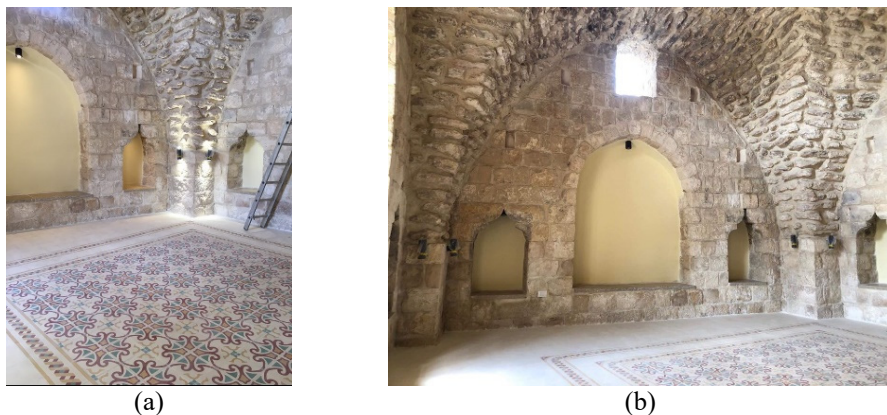
Figure 3: Cross vault in one of the palaces in Anabta, Nablus. (Source: Researcher, 2019.)

4. Vaults and domes: cross vaults were a common construction solution for palaces and castles, as shown in Fig. 3. On the other hand, domes were used in religious buildings like mosques; and in some of the palaces attics, as a decorative element on an octagon drum.

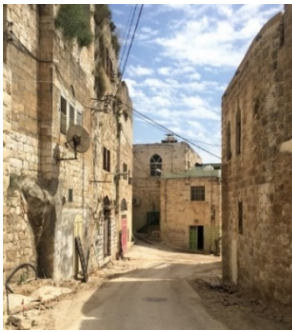
Figure 4: The double window in Anabta. (Source: Researcher, 2019.)

5. Openings: All openings in the palaces and castles in throne villages were small openings, except for the main entrances. Solid façades were one of the main architectural features. Openings were mostly oriented toward the courtyard, especially on the ground floor. The size of the windows gradually increased toward higher floors; for further adoption of the concepts of defense and privacy. The most common windows were the double rectangular windows, as shown in Fig. 4, in a residential neighbourhood in Anabta, Nablus.

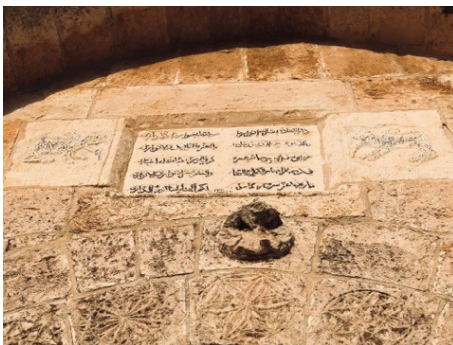
Figure 6: Stone relief at the entrance of Al Barqawi castle, Shoufa, Tulkarm.

6. Decorative elements: the decorative elements varied from reliefs of geometric shapes, plans and floral motifs, carved wood decorations, coloured ceramics, decorations and colouring of internal domes, as shown in Figs 5–7. Also, coloured wooden ceiling, Mashrabiya and the pottery openings on the roofs, which acted as decorative elements and provided privacy.

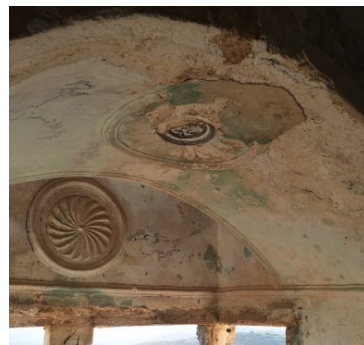
Figure 7: Colored ceramic above windows in Al Hakem castle, Kour. (Source: Researcher, 2019.)

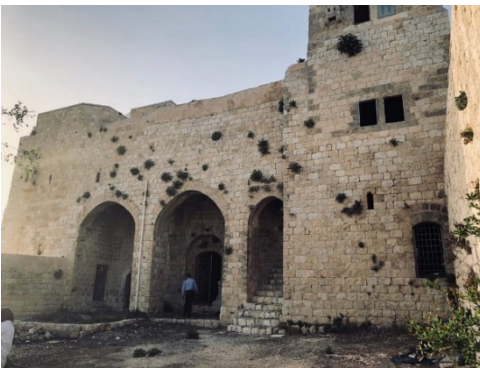
Figure 8: Al Hakem palace main entrance, Kour, Tulkarm.

The first, leaving the building uninhabited or unused for a long time with no periodic maintenance, results in problems such as roof leakage, as well as issues with garbage collection. The effect also extends to pose a real social threat among the youth, for example, problems such as drugs. Al Hakem Palace in Kour is an example of this case, which restored Kour Palaces that were left unused since then, as shown in Fig. 8.

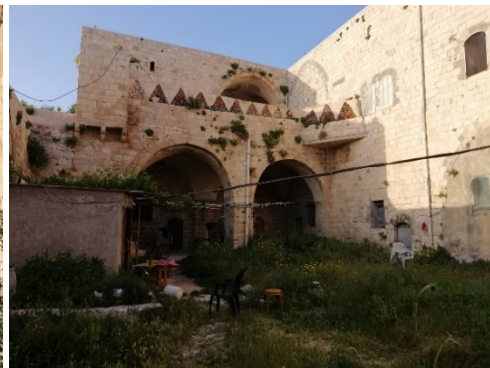
Figure 9: Interventions in Al Jayyousi palace, Kour, Tulkarm. (Source: Researcher, 2019.)

The second refers to situations where these palaces or castles were used as rental properties, which has led to a serious deterioration of the old buildings, due to the exploitation by mostly low-income residents other than their original owners [8]. The lack of responsibility and appreciation may cause the building serious damage; most of the historic palaces of Kour village were damaged, due to this reason. Changing the interior functions of the buildings spaces, adding or demolishing parts of the original building, changes its original nature, form, function and more importantly, its identity. Al Jayyousi palace in Kour has suffered from such interventions, which negatively affected the functioning of the courtyard, like the addition of an inconsistent external extension, built with concrete block, the dangling electrical wires and water sanitation pipes and closing of the arcades and some windows, as shown in Fig. 9.

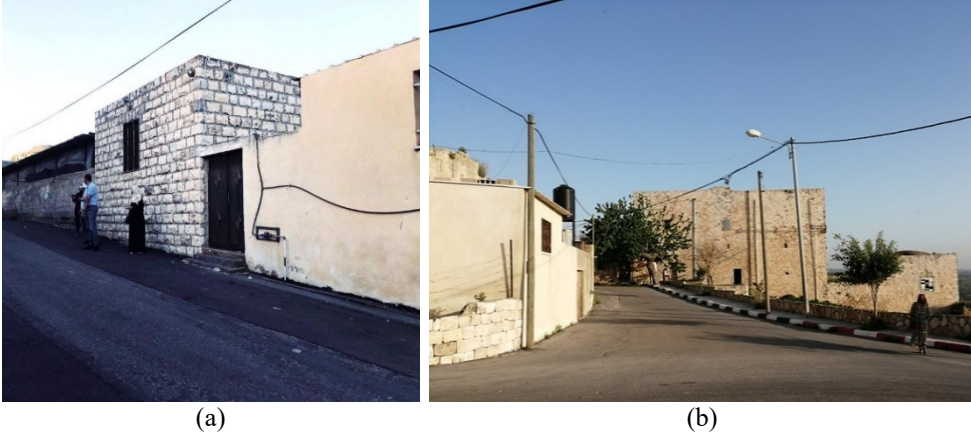
Figure 10: Plastered concrete block additions to buildings, Kour. (Source: Researcher, 2019.)

Uncontrolled and unplanned urban expansion is at present one of the main challenges to be highlighted, as both vertical or horizontal urban expansion require complete or partial demolishing of some old buildings; or on the other hand, the addition of inhomogeneous spaces to the original building. As for Kour; the buildings new expansion was mostly by the addition of plastered concrete block (Fig. 10). Personal interviews indicate high rates of immigration toward cities among the families with mid- to high-income, which explains the very low population rate increase: a total of 242 in 1997, 260 in 2007 and 292 in 2017 [9].

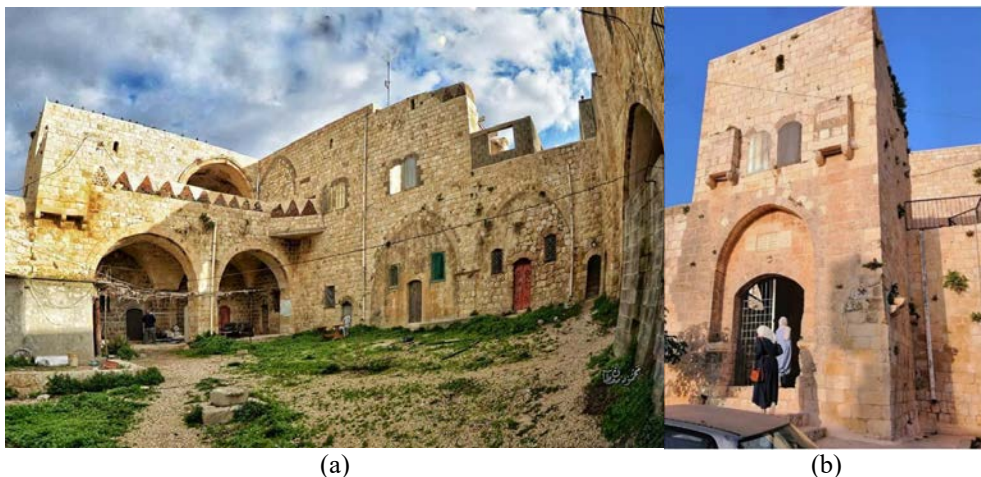
Figure 14: Al Jayyousi palace. (a) Courtyard; and (b) Entrance. (Source: Researcher, 2019.)

Al Jayyousi palace's design was based on the architectural form of Throne villages architecture; the defensive architectural features of high walls and small external openings are directly noticeable. Crossed vaults were used for ceilings, except for the governor's room, which had a dome ceiling; pointed arches were used at the entrance and the arcades surrounding the courtyard (Fig. 14(a)). Al Jayyousi palace has a large, monumental main entrance (Fig. 14(b)).
