Analysis of water consumption of a drip irrigation system compared with sprinkler installation: a case study in Sicily (Italy)

Abstract

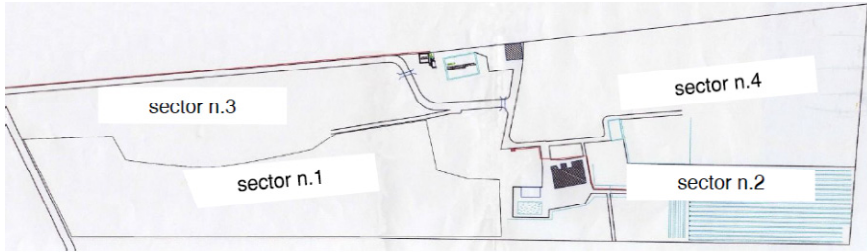
The crop, consequently to the reduction water supplied, has suffered a lot, especially in years of severe drought such as 2003 and with the passage of time, yields have declined a lot. Therefore, in 2008 the possibility to make a change was taken into consideration to prevent the situation from getting worse. In order to reduce production costs, in particular those related to water supply and consumption of electricity, and to increase yields, the sprinkler plant was replaced with a more modern subirrigation system. The plant is divided into four sectors of 1.6 ha (Figure 2); water comes through pipes with a diameter of 110 mm. The driplines have a diameter of 16 mm.

Figure 2: Drip irrigation scheme.

A distribution network is created that makes possible to explant and replant crops in different position without compromising the water supply. The pipes depth varies along the different areas of the plot. In places where there is the transit of agricultural means the driplines are placed at a depth of about 40 cm to

prevent the direct crushing. The high stoniness of the soil makes impossible to operate at high-depth and moreover the possibility of intervention in case of problems is to take into account. Both factors have determined the laying at a depth of about 10-15 cm. The project includes a water supply for a single tree of about 280 liters a week, corresponding to an average number of emitters equal to 11, as the water flow for a single emitter is 2.1 l h^{-1} and running period is of 12 hours a week.

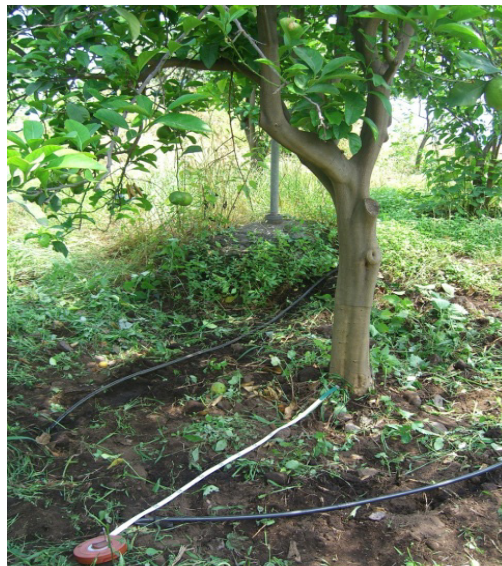
In the phase of gathering data for comparing the installations, 8 sample plants have been identified, 2 for each sector, for which the actual water supply was analyzed. The drippers surrounding the plant were first unearthed, later a circle with a radius of 1.5 meters was traced around the trunk and within the number of emitters was counted and the respective distance was measured. The driplines have a diameter of 16 mm with drippers every 50 cm (Figure 3).

Figure 3: Drip irrigation installation.
