An exploration of the historic core along Lake Pichola in Udaipur

S. Samant

School of the Built Environment, University of Nottingham, UK

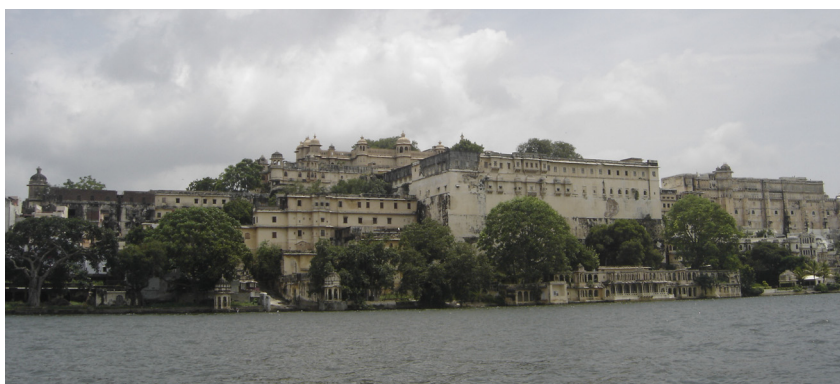
Figure 1: Palace and residential terraces overlooking Lake Pichola.

Cues from the topography led to the positioning of the main city-palace of Udaipur, the seat of political power, at the highest level on a rock mass that overlooked lake Pichola on its eastern edge (Figure 1), in the South-West direction of the city. Religion was the other powerful force that was physically manifested in Jagdish Temple built further down from the palace on a large mound (Naik, [2]). With the appearance of the lake and the palace which was the major controlling element of the city, by the end of the 16th century, a cluster of population grew around the palace in accordance with the need of the ruling family and people in general, and the religious and aesthetic needs of the time. Over time, the residential fabric expanded to either sides of the lake with several new additions and insertions, a process that still continues. This growth gradually led to the development of a township which was structured in such a way that all major streets led to the palace complex and that it could be located from any point in the city due to its prominent higher location.

of the ghats. The scale is however, broken down with the appearance of temple shikharas and compact clustering and terraces of dwellings within the residential area towards the north (Figure 1).

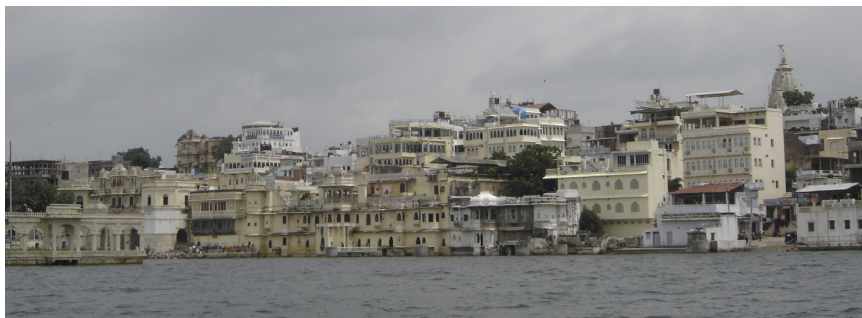
Figure 2: Additive layering of the built form.

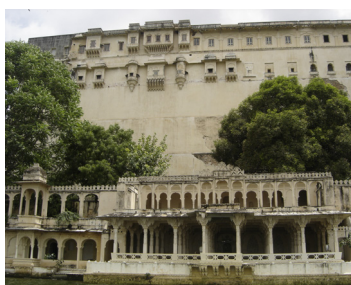
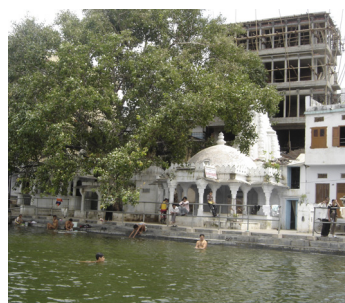
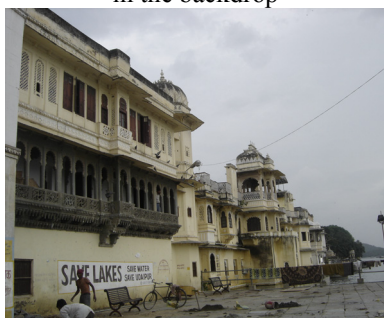
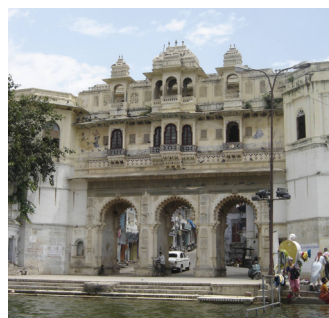
Pavilions along the lake with the palace in the backdrop

Temples along the lake

Haveli at Gangaur Ghat

Gangaur Ghat

Figure 3: Lake Façade and its elements.

The palace complex and its massive walls, havelis, temples, ghats and gates, pavilions and dwellings descend down to the water and lend a powerful linear edge to the lake on its eastern edge (Figure 3). The waterfront is also lined with a number of other structures in the form of an isolated cenotaph and domed pavilions known as chattries that functioned as memorials in immediate proximity with the water. Besides, there are pavilions and palaces such as 'Jagmandir' and 'Jagnivas' that are sited within the lake. Behind this edge lies a linear yet fluid clustered organisation of dwellings along narrow streets within the dense residential fabric.

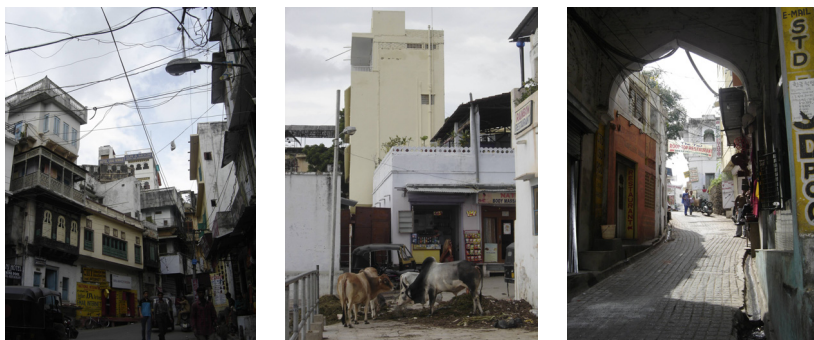
Figure 7: Visually decaying - Hoardings, graffiti, electric poles and open drains.

INTACH have undertaken listing and documentation of important heritage sites and monuments in and around Udaipur on the same guidelines as those of UNESCO. Important historic structures are already being conserved. However, these do not include other buildings or precincts of special cultural, traditional or socio-economic significance that are also worthy of preservation. Buildings, which are not of particular religious or historic relevance, have been ignored by the local community as well as authorities and stand in poor condition as a consequence of continued neglect. Building surfaces have not been maintained and are vulnerable to vandalism. Decorative elements of the facade have been damaged and covered with posters and graffiti, causing further clutter (Figure 7). Large scale hoardings and paintings are displayed on/across monuments, rocks, trees, parks. Due to lack of resources, living conditions of many residential properties owned and inhabited by poor families have not been maintained and are in various states of deterioration causing dilapidation (Figure 7).

Growth in tourism has led to tremendous increase in vehicular traffic causing air and noise pollution, and severe congestion along the access routes that were primarily designed for pedestrian use. Streets are also congested with stray animals and encroaching shopkeepers and hawkers. The area suffers from poor infrastructure and marginal inward investment resulting in lack of amenities, inadequate and highly unhygienic utility services and absence of an appropriate disposal system causing significant amount of litter and presenting a visually

decaying picture (Figure 7). The general quality of the environment is very poor due to obnoxious smells from open drains and wastes of all sorts. There is a tremendous growth in motorized vehicle, physical and visual congestion. Awareness campaigns about environmental issues, sanitation and health have been conducted for the local community in the recent past. However they have failed to bring about change in peoples' attitudes.

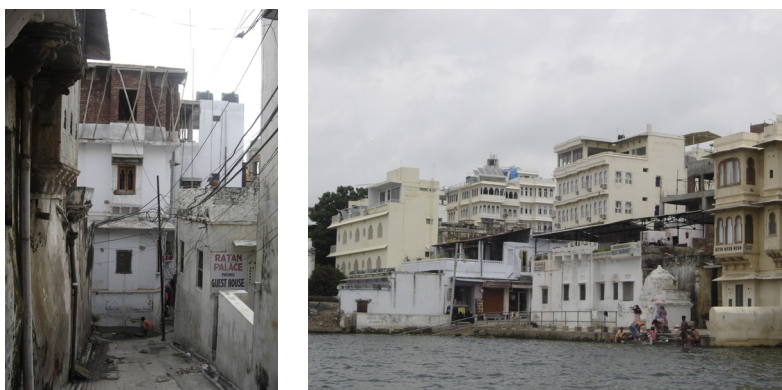
Figure 8: Unsympathetic new insertions.

It is evident that several new insertions and unlawful/unsafe additions and alterations that are not sympathetic to the scale and traditional vocabulary of the area have been built over the years. Ruins have been built over or used as a source of building materials reflecting lack of respect for the past and vision for the future. Views to historic monuments have been obscured by new structures, electric poles and wires. High rise concrete structures are jostling incongruously against old lime-mortar havelis and buildings (Figure 8).
