PROTECTIVE ROOF SYSTEMS FOR ARCHEOLOGICAL SITES IN MEXICO

FRANCISCO J. SORIA, LUIS F. GUERRERO & ALMA B. GARCÍA
Built Heritage Conservation and Reuse Research Group,
Metropolitan Autonomous University-Xochimilco, Mexico

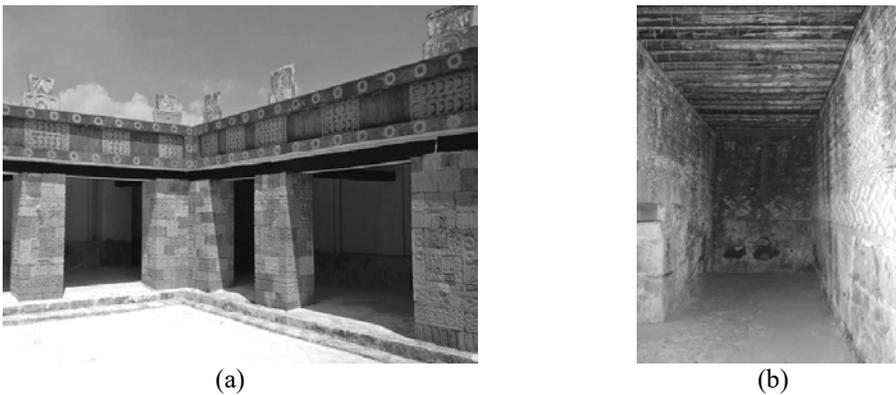
Figure 1: (a) The Temple of Quetzalpapalotl in Teotihuacan, after the restoration. The roof protected the vestiges of the site but at the same time altered conditions of authenticity; (b) Mitla in Oaxaca, also rebuilds the roof tops. (Photos: L. Guerrero.)

Examples of this solution of integrating roof systems that are very similar to the original ones, can be seen in several sites, designed with different criteria. The Temple of Quetzalpapalotl, was restored by incorporating a contemporary roof that goes beyond just recovering the spatiality and lost volumes.

Another well-known case is the site of Mitla in Oaxaca, where a roof made of wood logs that resemble the original building system was added. In both cases, the main idea was directed to restore spaces, scales, textures, in other words, the whole architectural ensemble.

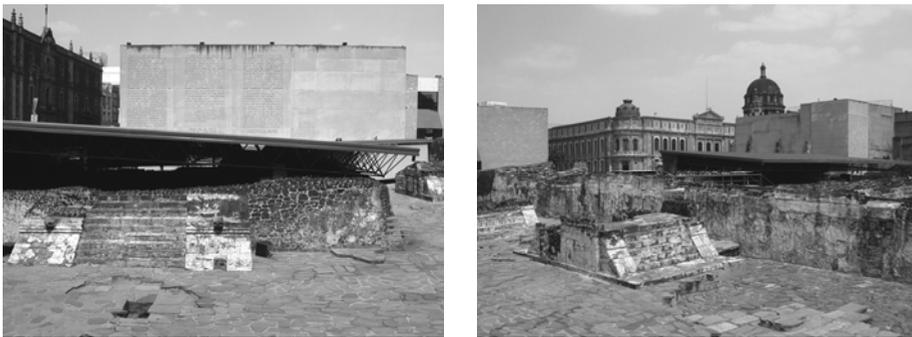
Figure 2: In the Great Temple site, discovered in México City's historic center, the incorporation of protective roofs was necessary in order to safeguard pre-Hispanic vestiges with original decoration. Not all the site was covered; rather, a selective criterion was applied, shielding only a few notable structures. (Photos: L. Guerrero.)

The variety in the design of these types of roofs is huge, from structures made of steel, aluminum and glass that contrast with the archaeological environment, as is the case of the “Templo Mayor” in México City, to roofs built with local materials such as wood, palm leaves and stone, made to cover altars in the Mayan region. Also, mixed techniques have been used, which combine more resistant elements as concrete columns to support roofs made of wood and straw.

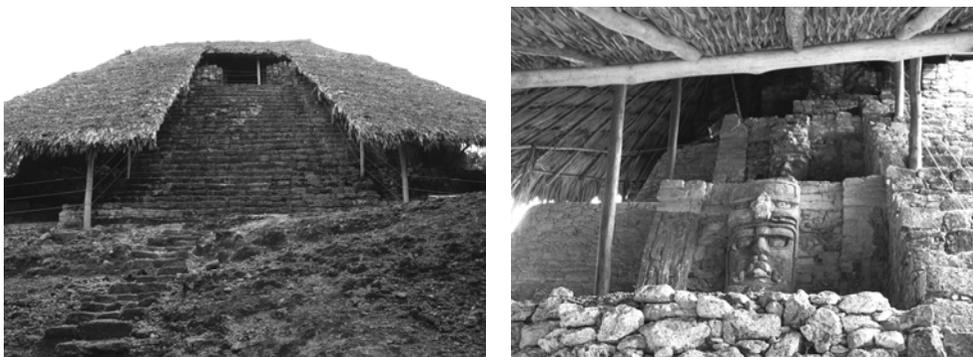
Figure 3: Sites in the Maya area such as Kohunlich have been protected with small, lightweight covers, using natural materials which minimize the physical and visual impact on the structures. (Photos: L. Guerrero.)

A field that is increasingly developing is the use of smaller shelters (micro-roofs) which by their weight and usage of regional materials, can be incorporated much better into the cultural context, without posing a risk to stability and reducing visual impact on the landscape. In most cases, the idea is to complete the construction system, much in a similar way to the ones that existed or, at least introduce a structure that is compatible with the characteristics of the pre-existing ones, as a means for adequate conservation. Successful examples of intervention with an important decrease of the physical and visual impact on the heritage environment can be seen in many sites of the Maya area, as Ek Balam, Mayapán, Kohunlich, Edzná and Coba, where small covers made with wooden or bamboo struts and stringers that support a mesh of guano palm (*Sabal Mexicana*) have been implemented.

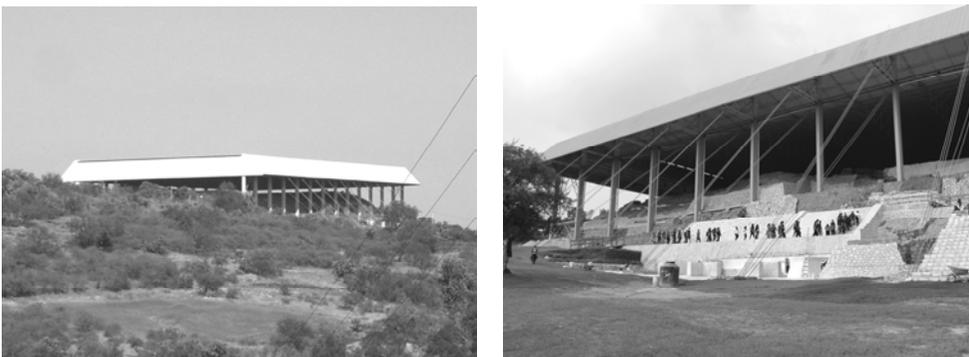
Figure 4: The large structure that covers the site of Cacaxtla remains the biggest intervention made over an archaeological site in the country. It has had negative effects in the long run over the ruins, to the point that its removal has been debated. (Photos: L. Guerrero.)

The use of large span structures to cover archaeological sites, made of steel and concrete has not become widespread in Mexico. While it is a growing trend around the world (see sites as Catalhoyuk, in Turkey or Kourion in Cyprus) in our country its implementation is still quite limited, even though we have a vast number of archaeological sites and ruins with huge areas of highly vulnerable material. The best-known case of large coverings is that of the acropolis of Cacaxtla, which proved to be very controversial because of the bad experience that it has represented, for more than two decades after it was built. The intervention in this important archaeological site, mainly built with earth, located in the State of Tlaxcala, in the center region of the country, included an enormous steel structure with metal panels for the roofing, with a surface of nearly 11,000 m², and throughout the years has produced a series of problems that must be pointed out:

- The destruction of adjacent structures for the construction of enormous foundations for columns and tension anchors.
- The acceleration of wind under the cover that increased erosion of the ruins.
- The removal of rain and hail from the roof top; the accumulation of ice after a hail storm made part of the structure collapse just a few years ago.
- Negative visual impact on the surrounding landscape.
- High maintenance costs.
- Drying and moisture loss of the earthen built heritage remains.
- Development of bird colonies, which inhabit inside and drop debris on the archaeological ruins.

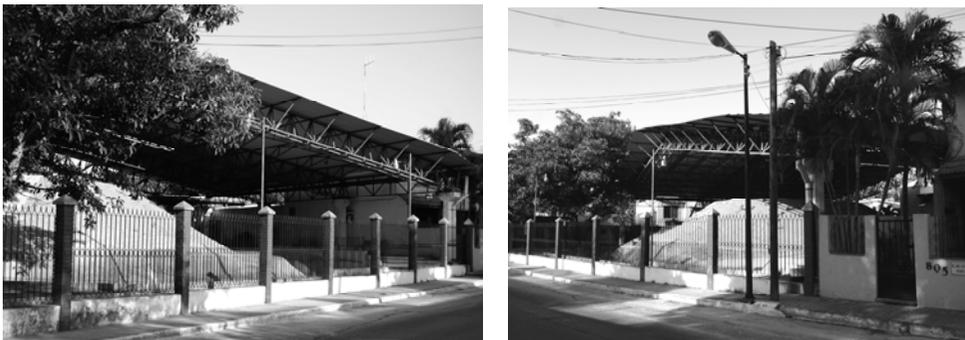
Figure 5: The design of protective covers with “standard” criteria usually does not take care of specific conditions as proper rainfall eviction, maintenance requirements, energy needs or aiding visitors. The case in Tampico, Tamaulipas is a simple horizontal barrier that does not provide a more comprehensive solution. (Photos: L. Guerrero.)

However, this consideration ignores the fact that normally excavated sites are neither symmetric nor possess qualities of spatial organization that will ensure that the decision to place vertical supports at a certain point will coincide with similar conditions in the rest of the archaeological site. This problem is enhanced by the fact that these locations are excavated and protected in stages, according to the ongoing process of exploration and conservation, which normally do not conclude with the opening of a site to the public, but continue for months or years; so, the shape of the protective covers should not be predetermined, but developed in function of the spaces and areas that must be protected.
